Revised
RESERVE STUDY
Parkwood Village
Homeowners Association

Madison, Wisconsin
Inspected - October 14, 2020
Revised - August 24, 2021

Parkwood Village Homeowners Association
Madison, Wisconsin

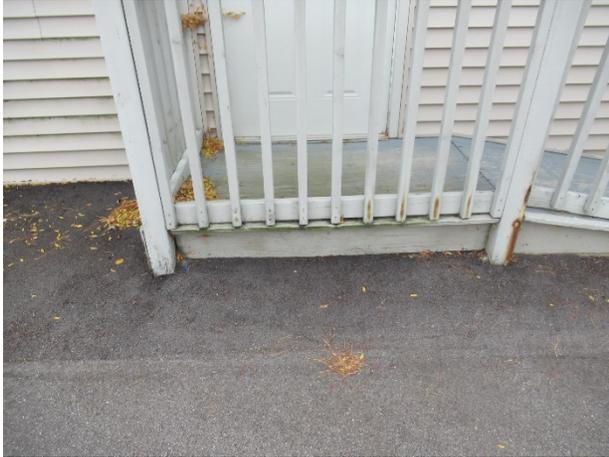
Wood rot and rust at clubhouse ramp

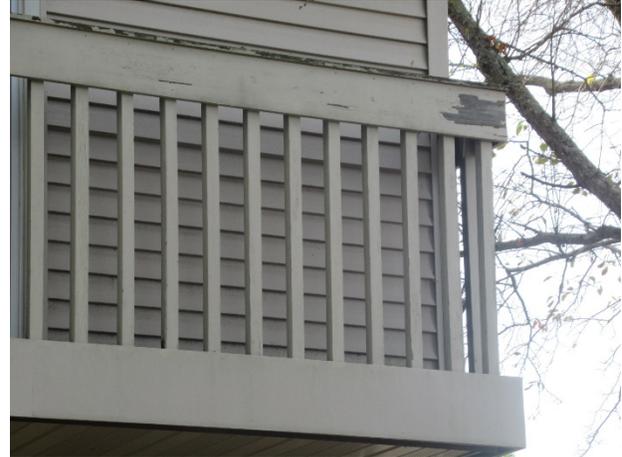
Condition: Fair overall condition with detached components, weathered wood and paint deterioration evident

Paint finish deterioration (Unit 120 shown)

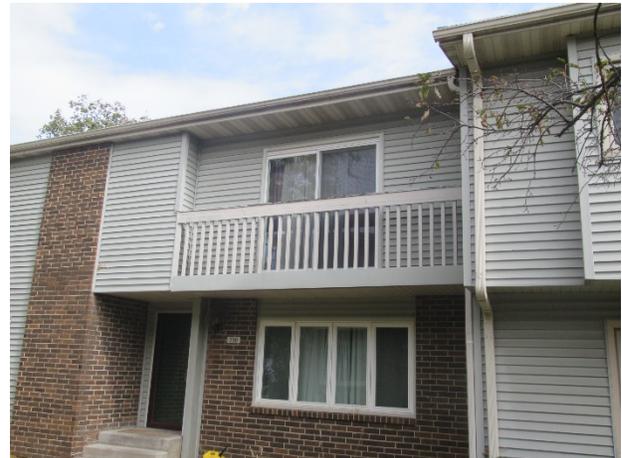
Paint finish deterioration (Unit 130 shown)

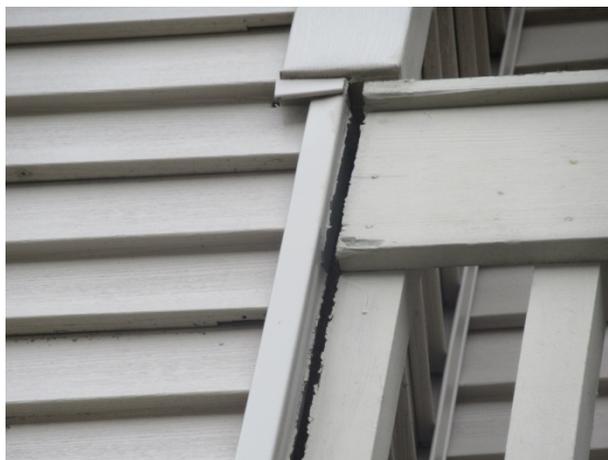
Paint finish deterioration (Unit 212 shown)

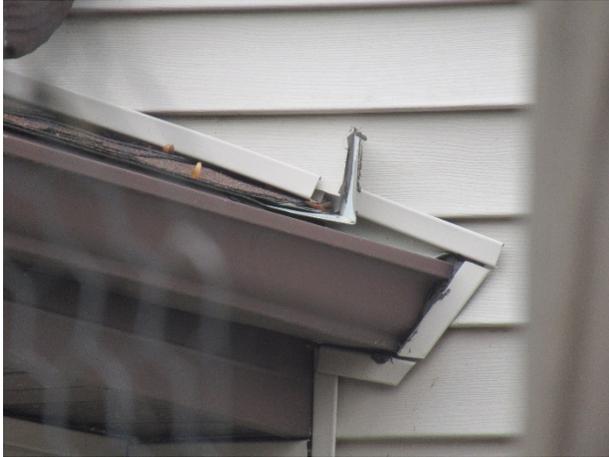
Flashing kicker at garage (Unit 6652 shown)

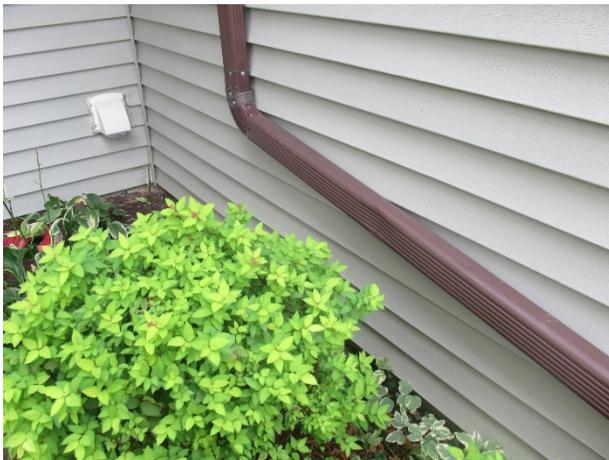
Condition: Fair overall with deflection, fastener rust, leakage at seams and dented sections evident

Dent on downspout (Unit 14 shown)

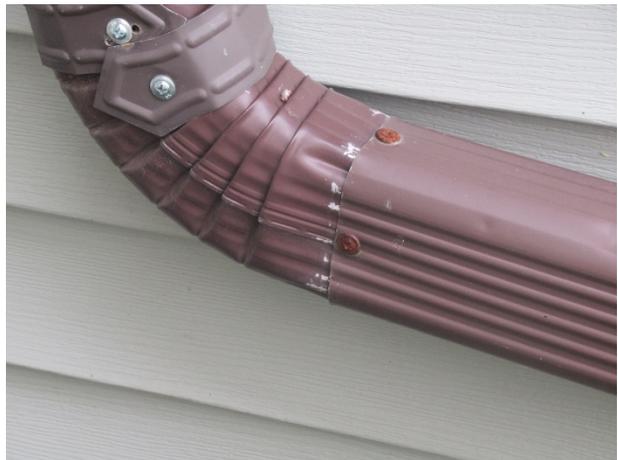
Rusted fasteners indicate old age (Unit 14 shown)

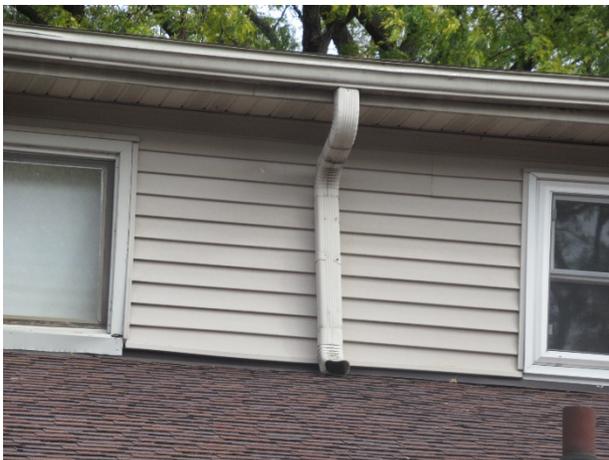
Downspout discharge on roof

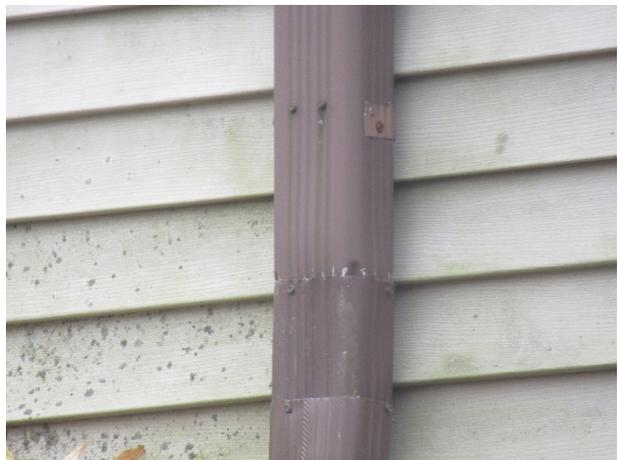
Repairs on downspout (Unit 34 shown)

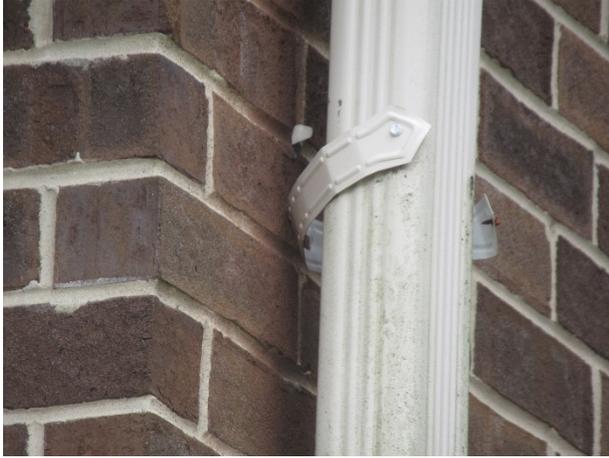
Damaged downspout brace (Unit 208 shown)

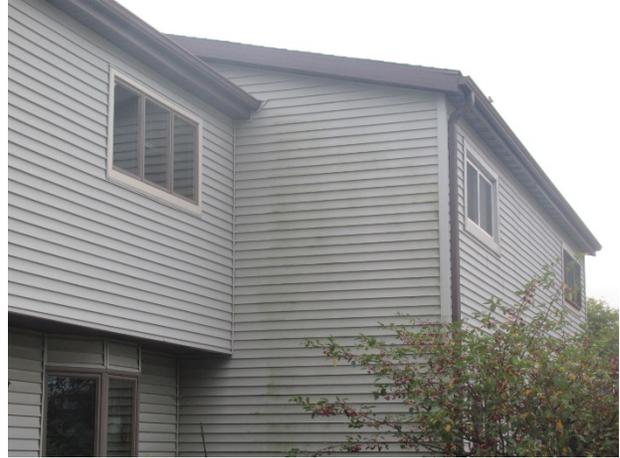
Gutter overflow evidence on vinyl siding (Unit 8 shown)

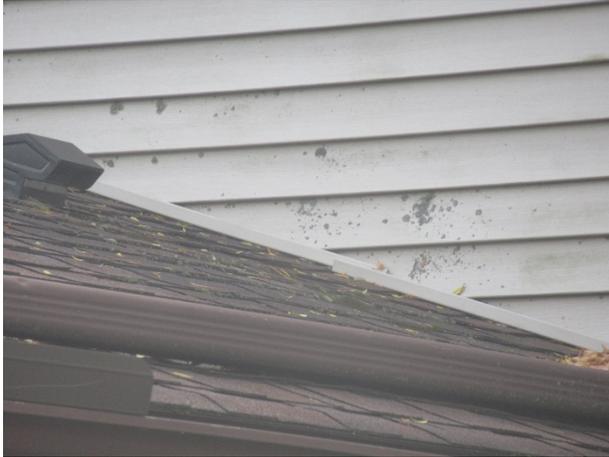
Condition: Fair to poor overall with cupped, organic growth, weathered and granular loss shingles evident from our visual inspection from the ground. Management reports a limited history of ice dams. Management informs us about construction defects involving the soffit vents. The exterior of the soffit is perforated aluminum for ventilation, however plywood lines the interior. Reportedly insufficient holes were drilled into the existing plywood may increase the risk for ice dams.

Organic growth on roof (Unit 6616 shown)

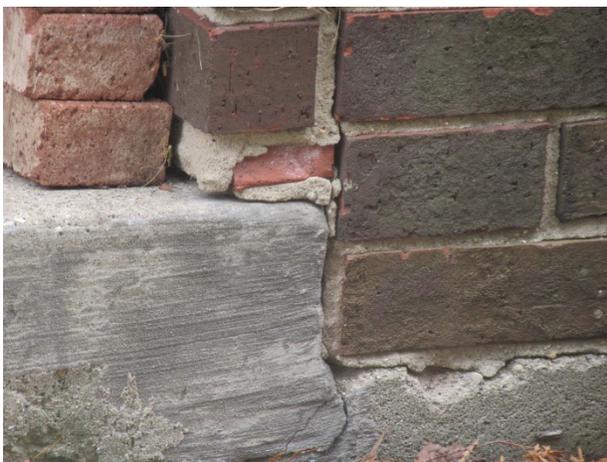
- Extensive previous repairs evident
- Efflorescence is not visible
- Lintels exhibit rust jacking (cracks in the masonry due to rusting and expanding of the lintel steel)
- Masonry exhibits cracks, cracks are systemic at units with foundation settlement evident
- Masonry exhibits spalls
- Mortar deterioration is evident
- Mortar joints are tooled
- Weeps and flashing at lintels are not visible

Repairs and mortar gaps evident (Unit 2 shown)

Useful Life: We advise a complete inspection of the masonry and related masonry repairs 6- to 10-years to forestall deterioration.

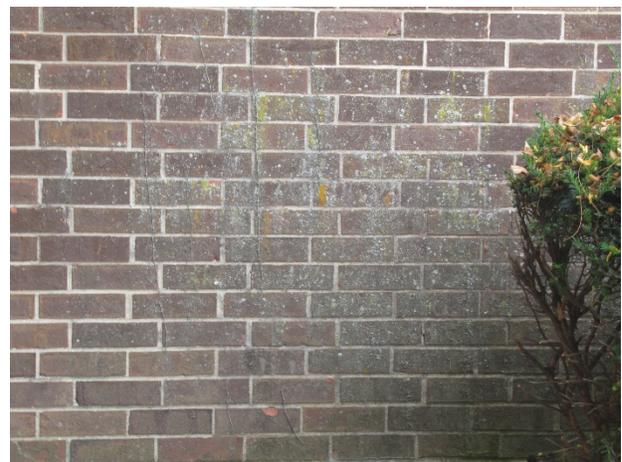
Organic growth (Unit 6634 shown)

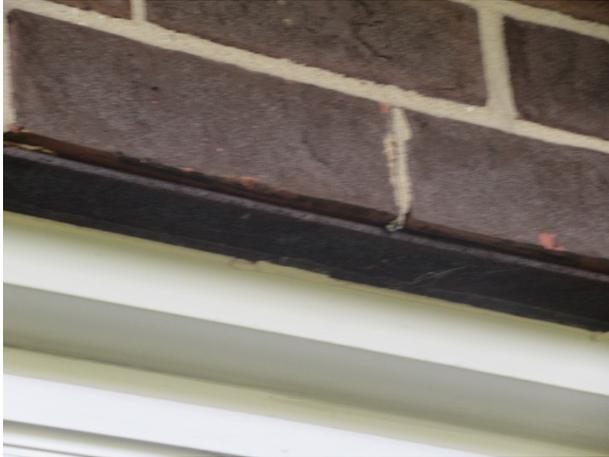
Rusted lintel (Unit 6634 shown)

Component Detail Notes: We recommend an inspection and repair of the lintels as necessary. Lintels are structural supports or beams above windows and doors. Fatigued lintels also allow the direct penetration of storm water into the wall assembly. These inspections should locate areas of rust on the lintels and cracks or other structural damage to the walls around lintels. The contractor should remove any areas of rust, prime and paint these lintels. Paint protects and maximizes the remaining useful life of the lintels and therefore the exterior wall systems. Structural damage can eventually lead to costly replacements of lintels and surrounding wall systems. The following diagram details a typical metal lintel and weep system and may not reflect the actual configuration at Parkwood Village:

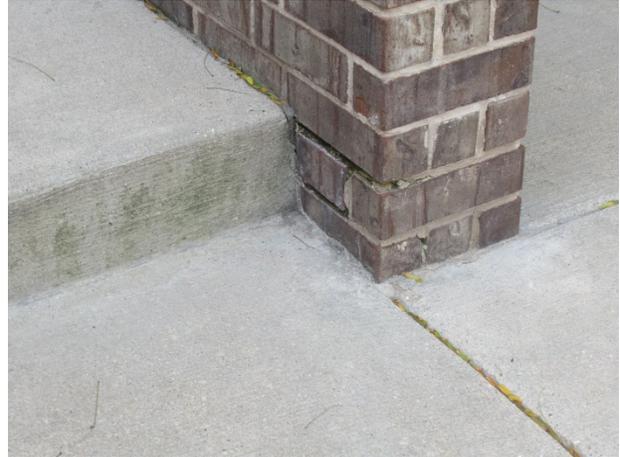
Mortar deterioration (Unit 6614 shown)

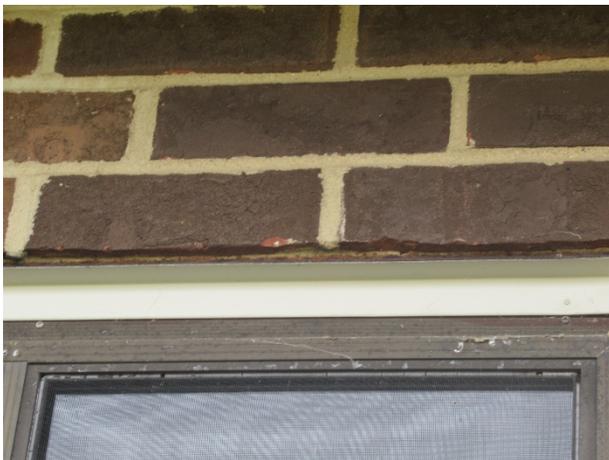
Rust at lintel (Unit 18 shown)

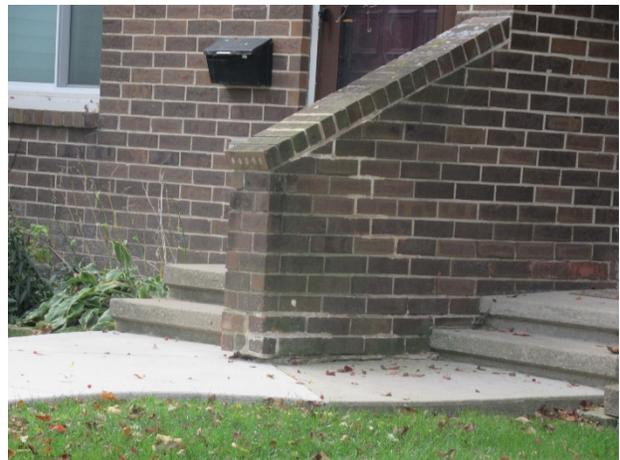
Mortar repairs and deterioration (Unit 146 shown)

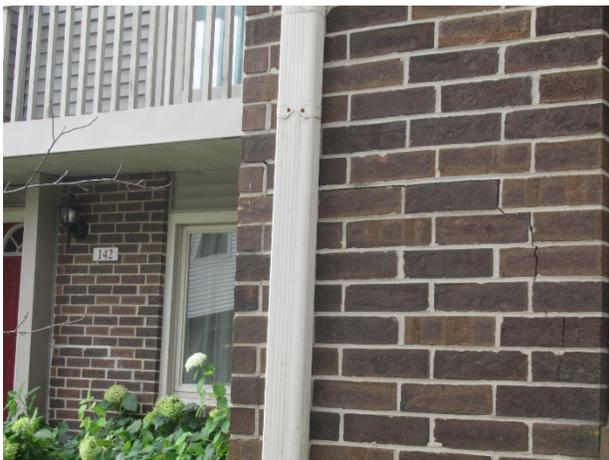
Step cracks (Unit 142 shown)

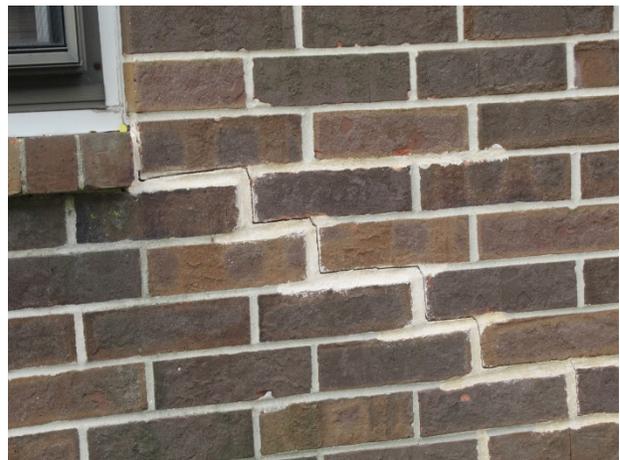
Mortar repair and developing step cracks (Unit 142 shown)

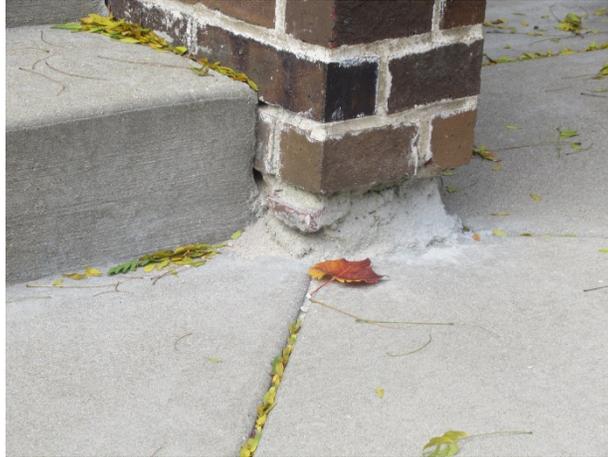
Masonry disintegration

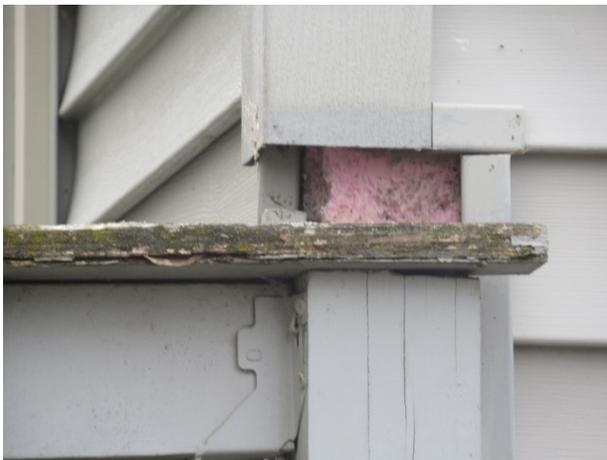
Condition: Fair overall with warped and damaged and loose sections evident

Exposed insulation (Unit 2 shown)

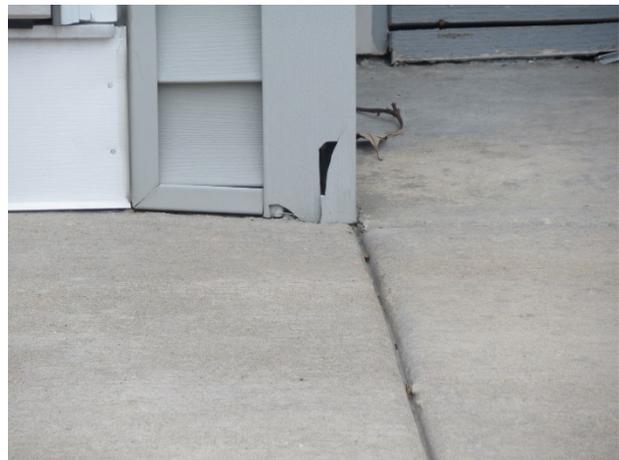
Vinyl trim damage (Unit 14 shown)

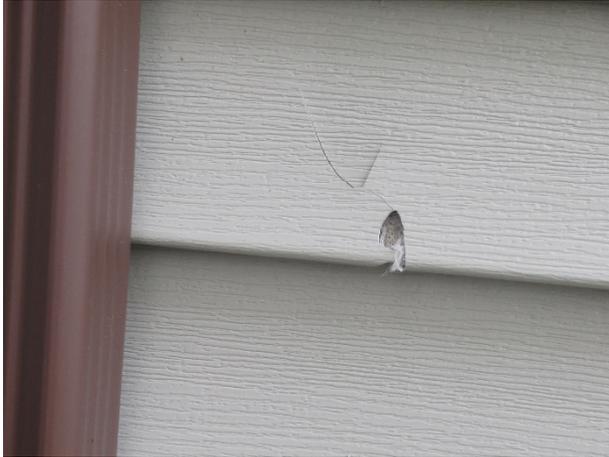
Damage on vinyl siding

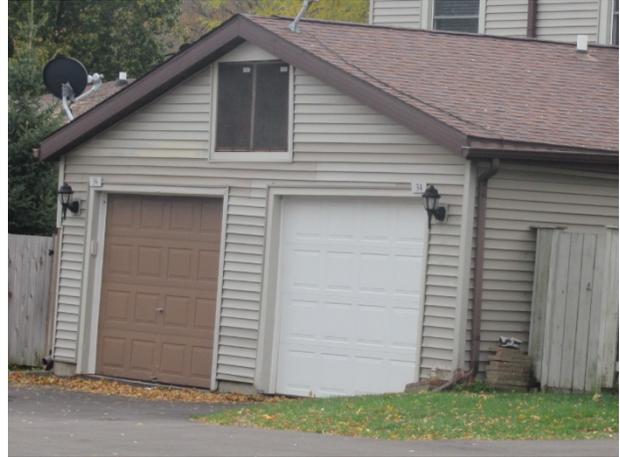
Mismatching colors (Unit 34 shown)

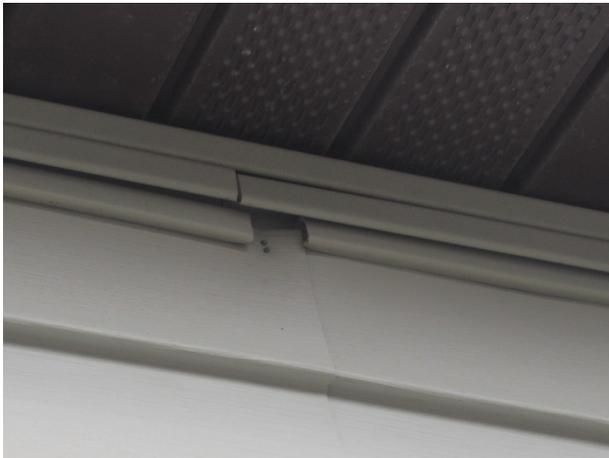
Siding repair and triple J-channel (Unit 214 shown)

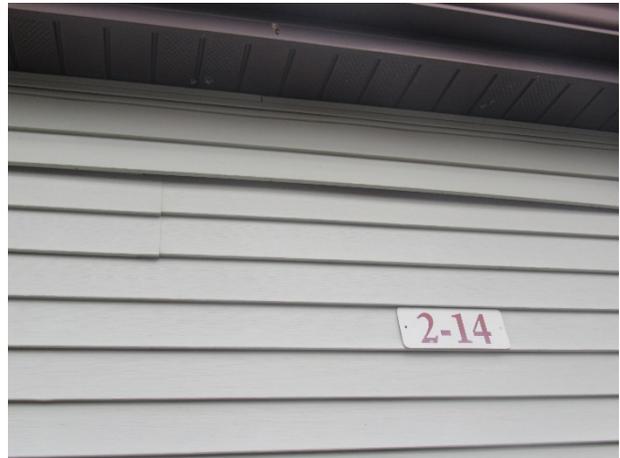
Loose boards (Unit 214 shown)

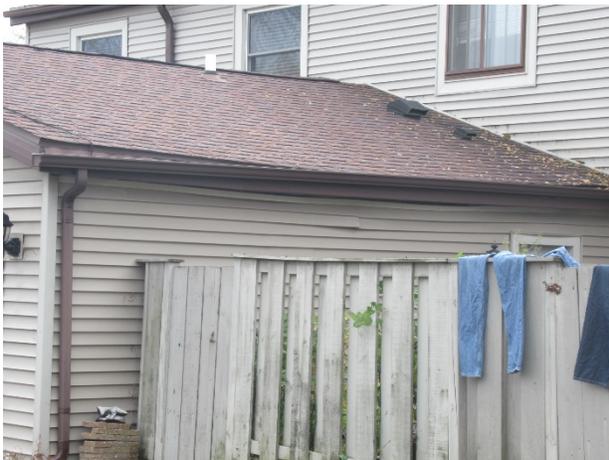
Loose siding boards (Unit 34 shown)

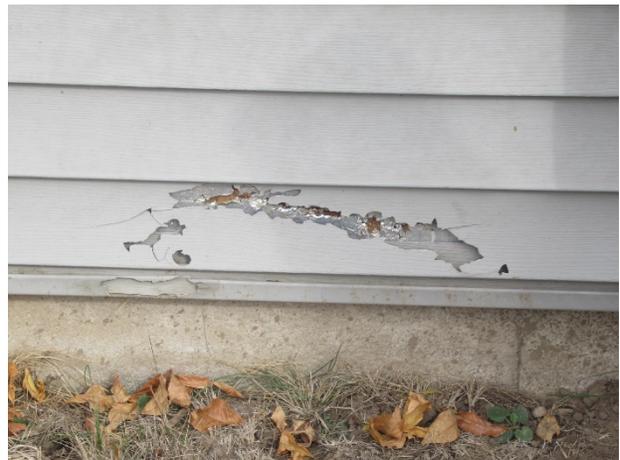
Siding and flashing repair

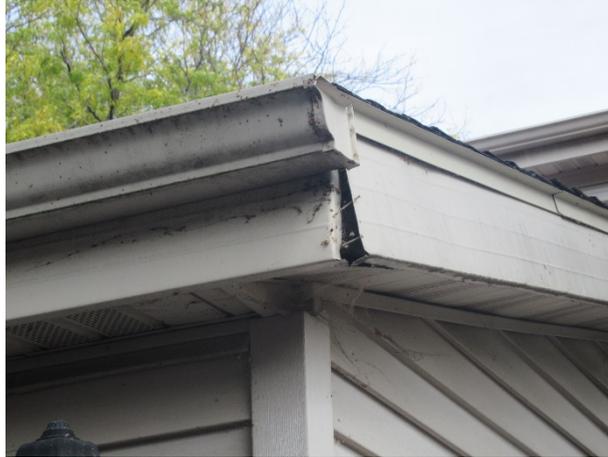
Popped nails at fascia (Unit 114 shown)

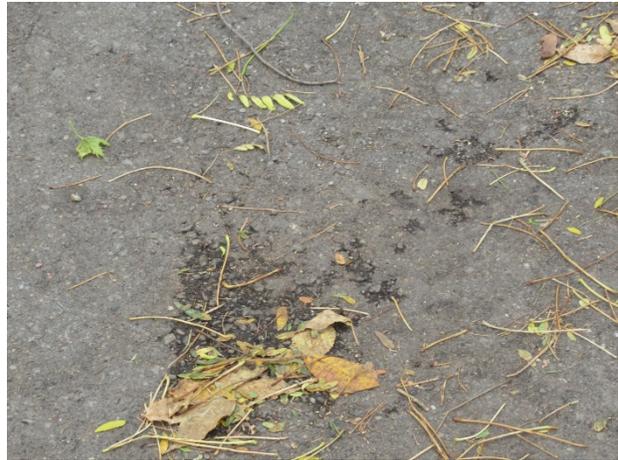
Raveling spot

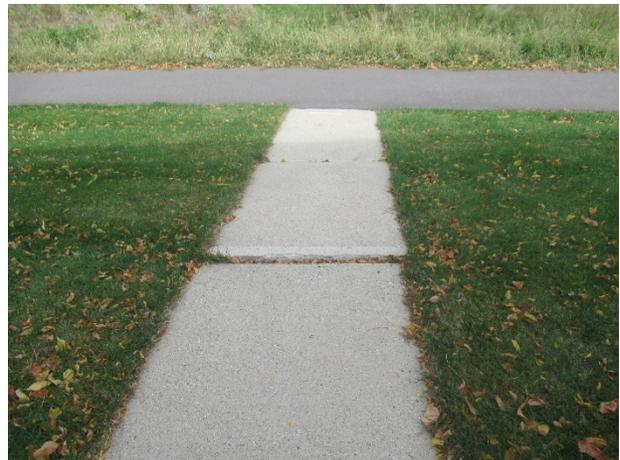
Settlement and trip hazard

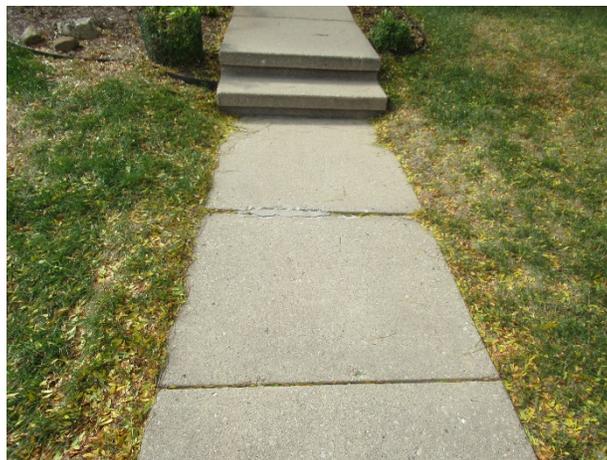
Repaired crack

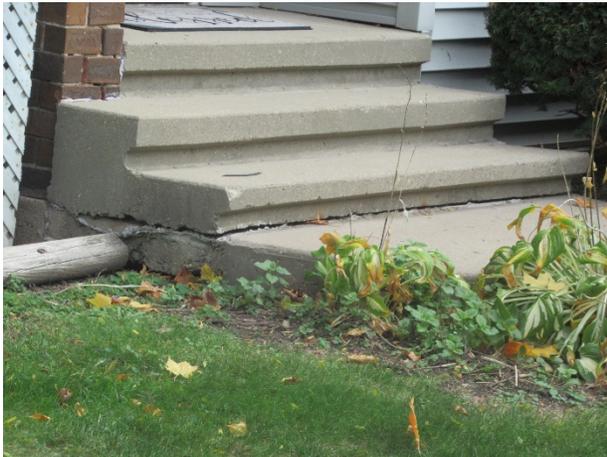
Condition: Good to fair overall with systemic settlement at the units with foundation issues evident

Settlement (Unit 144 shown)

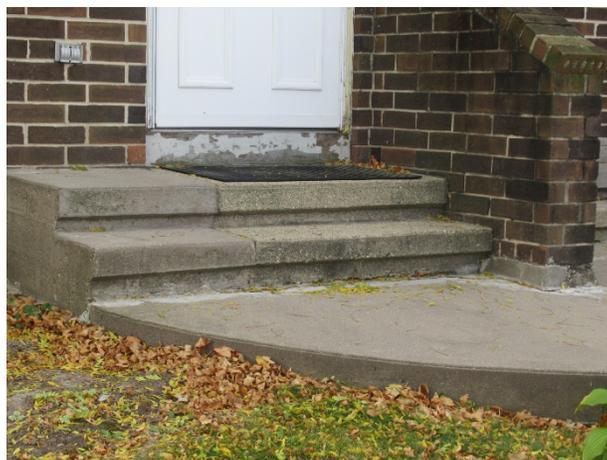
Crack repairs due to settlement (Unit 104 shown)

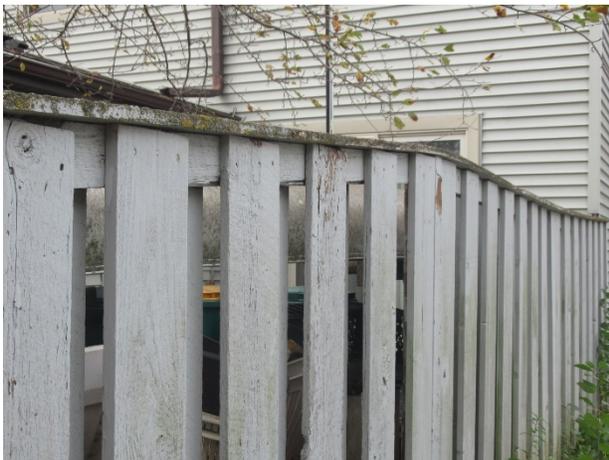
Weathered wood (Unit 2 shown)

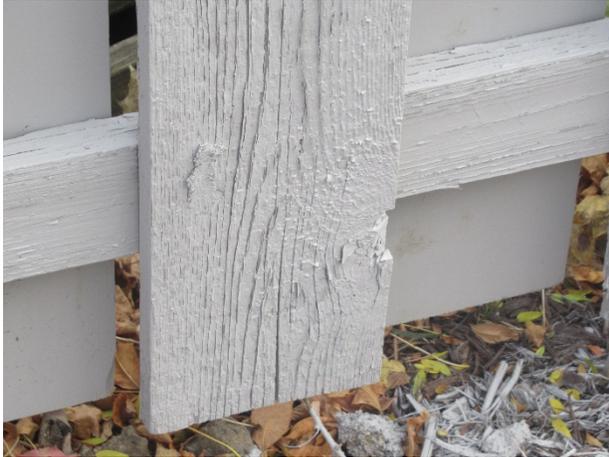
Condition: Good to fair overall condition with leaning sections and wood rot evident

Stained fenced with wood rot (Unit 120 shown)

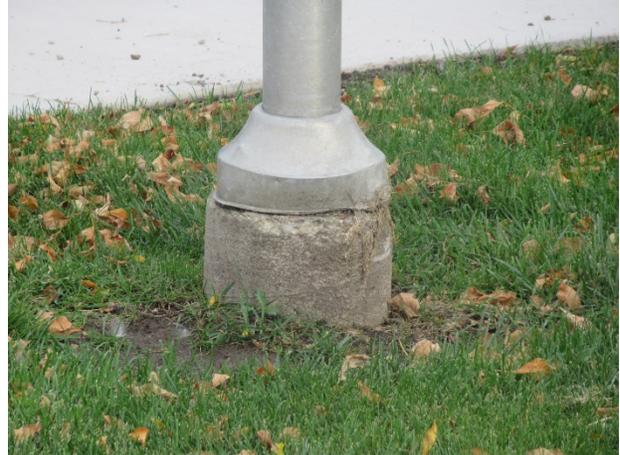
Damaged base cladding

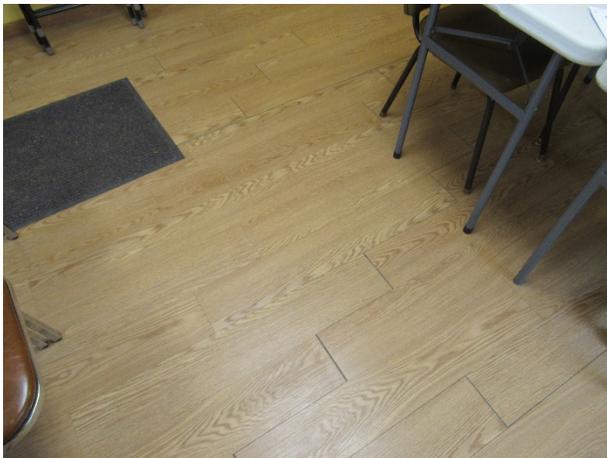
Condition: Fair overall with gaps at seams

Gaps at seams

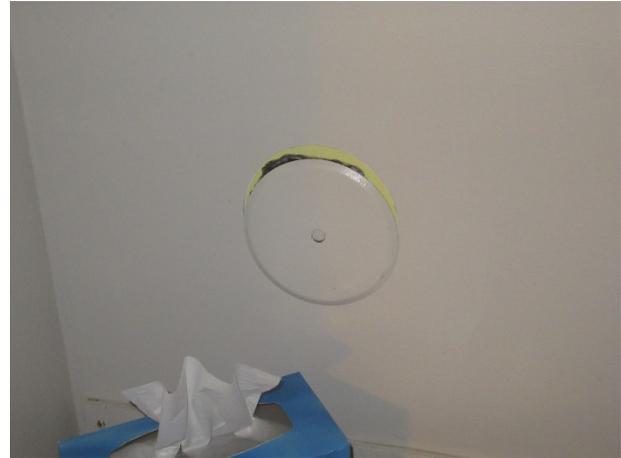
Loose cover

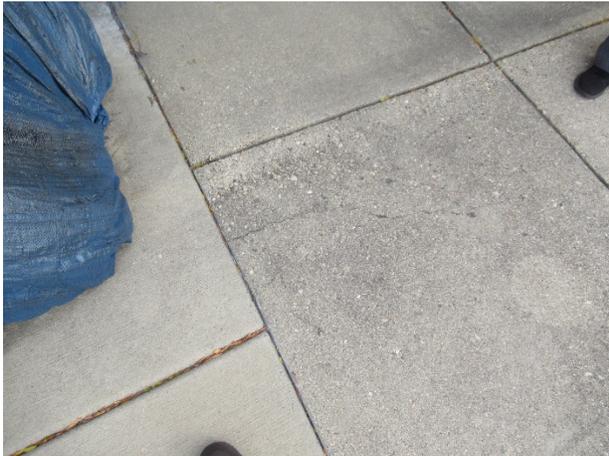
Condition: Good condition with hairline cracks evident

Hair line crack

Useful Life: The useful life of a concrete pool deck is up to 60 years or more with timely repairs. We recommend the Association conduct inspections, partial replacements and repairs to the deck every 8- to 12-years.

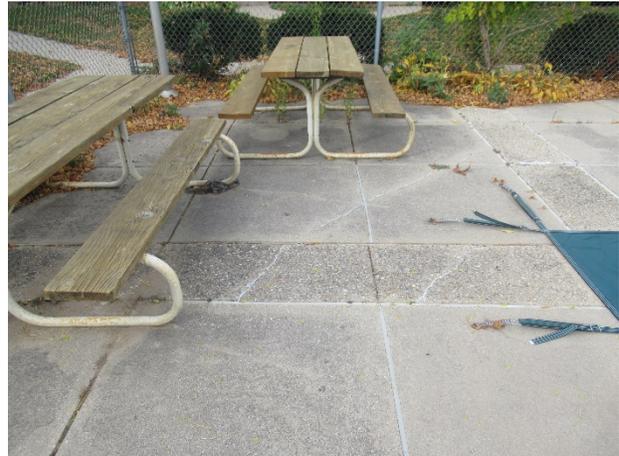
Repaired cracks

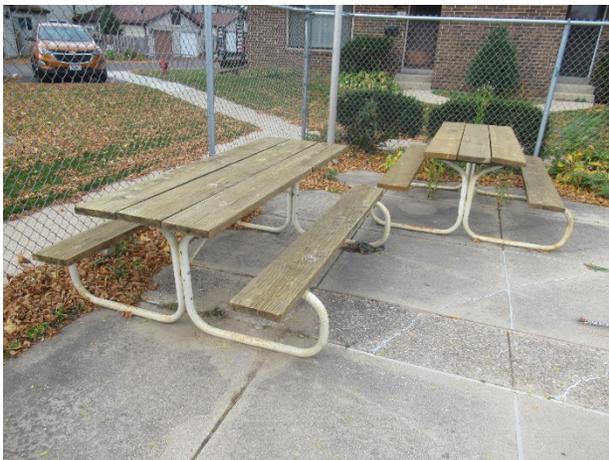
Condition: Fair to poor overall

Benches at the pool exhibit rust
