# Parkwood Village

## Homeowners Association

Inspected: November 12, 2024 • Revised on: July 23, 2025  
Madison, WI

RESERVE STUDY

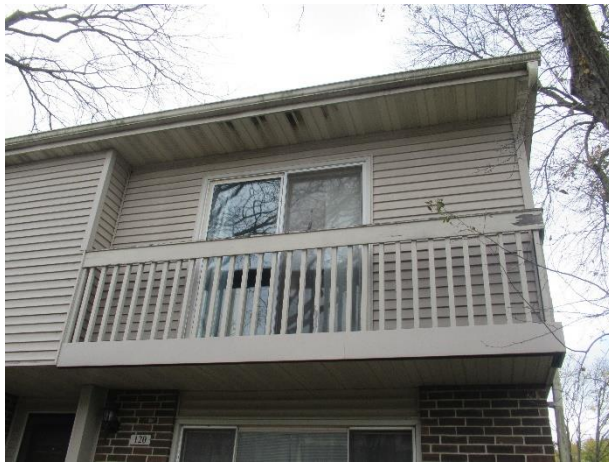
**Condition:** Fair overall with weathered and deteriorated wood and peeling paint evident.

**Balcony overview**

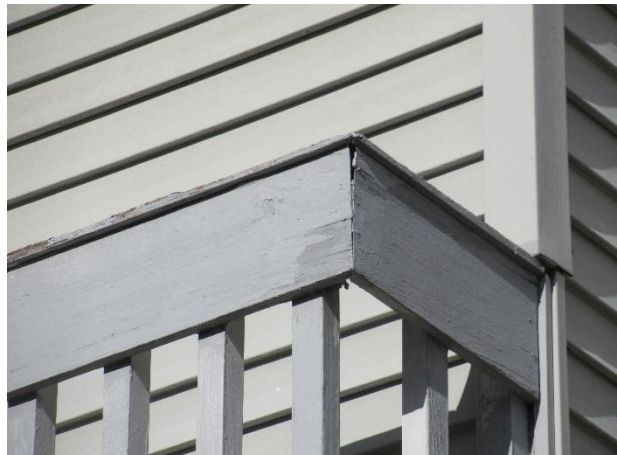
**Weathered and deteriorated wood components**

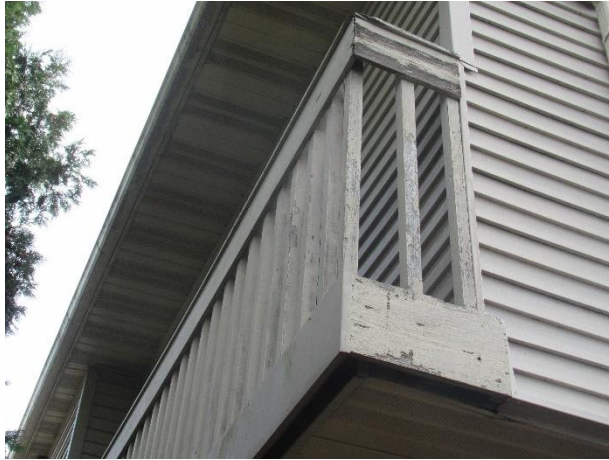
**Weathered and deteriorated wood components**

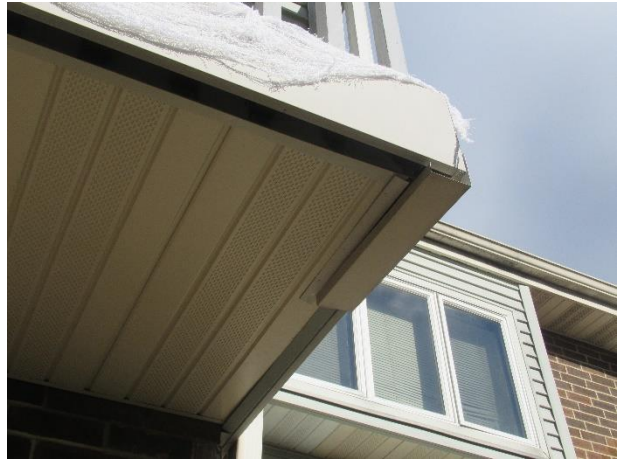
**Balcony soffit and trim**

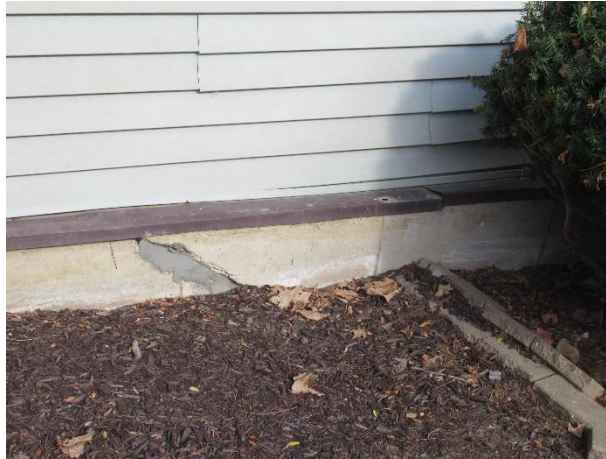
of the buildings at the perimeter at the property. These repairs have historically included installing steel brackets and the addition of piers from within the basements. We are informed that the need for these repairs has decreased since our 2020 site visit. However, we note several indicators of excessive settlement including roof deflections and masonry cracks, movement and apparent out-of-plumb locations. We include related recommendations in our narrative “Walls, Masonry”.

**Previous foundation repair**

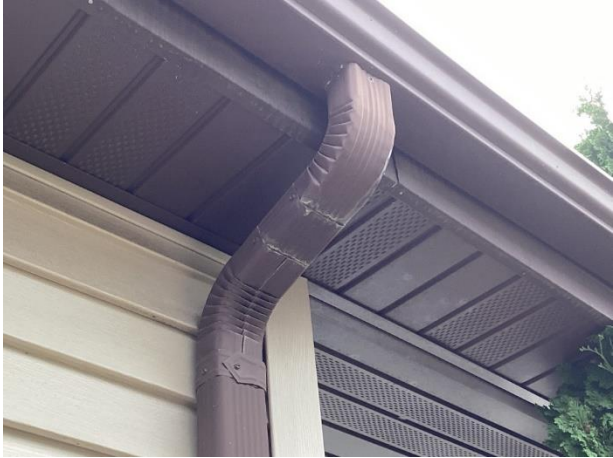
**Condition:** Fair to poor overall with frequent deflection, fastener rust, leakage at seams and dented sections evident.

**Evidence of leakage at seams at clubhouse**

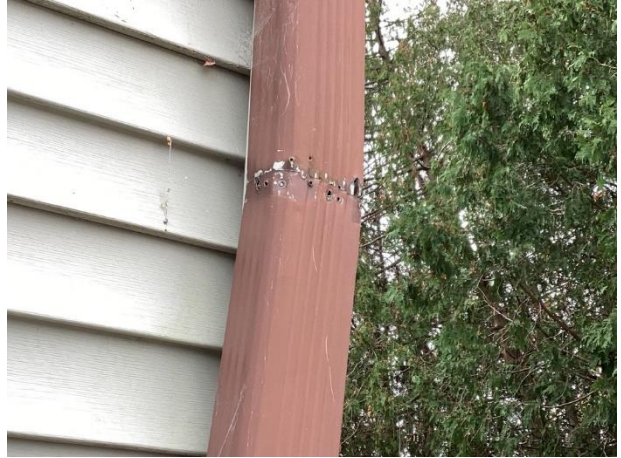
**Multiple fastener holes**

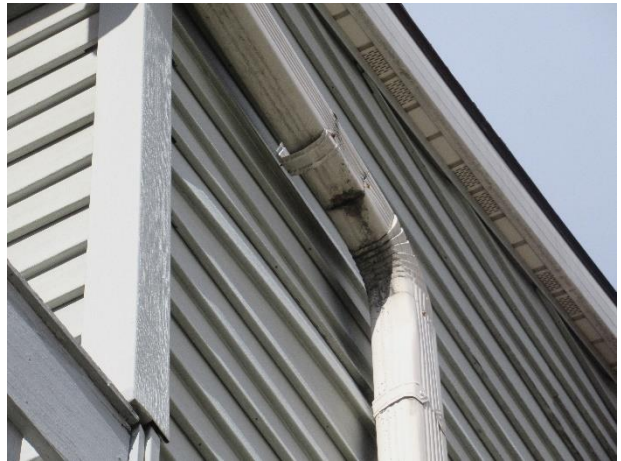
**Evidence of leakage at seams**

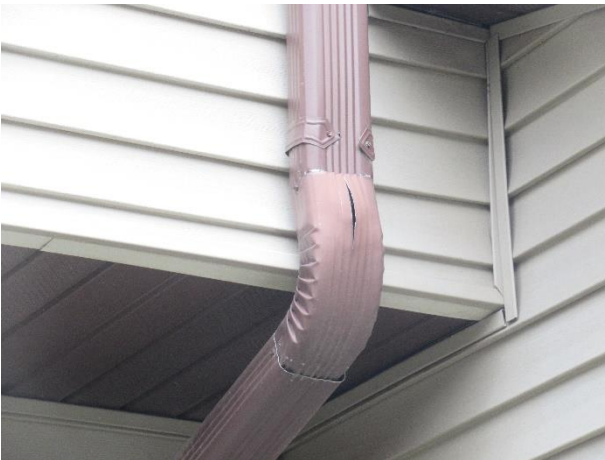
**Split downspout**

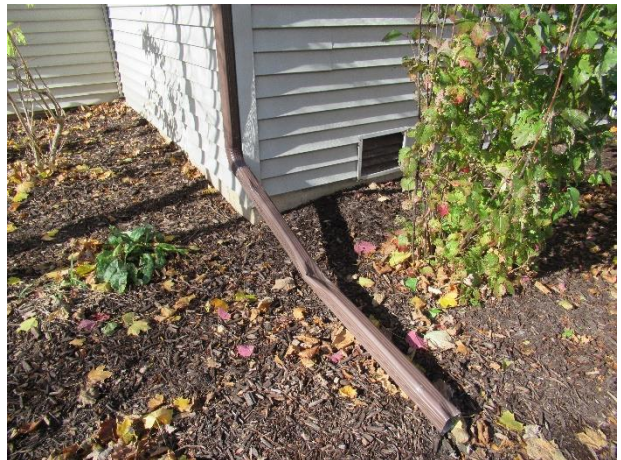
**Damaged downspout**

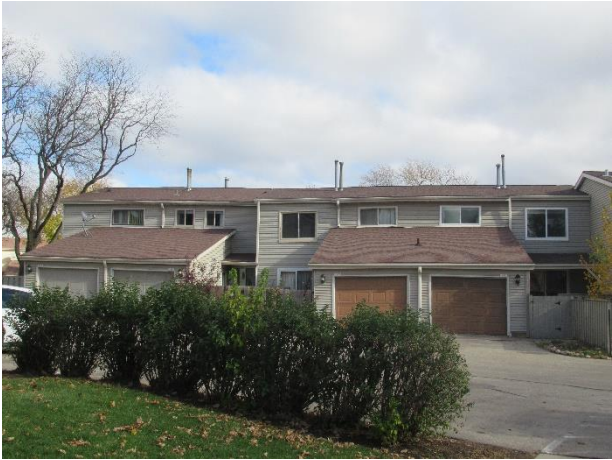
In addition, we note roof deflection apparently due to building movement and/or settlement, particularly at garages. We note several indicators of excessive settlement including roof deflections and masonry cracks, movement and apparent out-of-plumb locations. We include related recommendations in our narrative "Walls, Masonry".

**Asphalt shingle roof overview, note deflection in roofs likely due to building settlement**

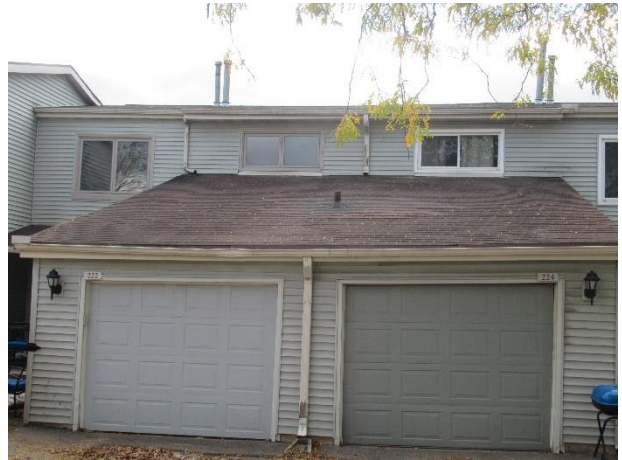
**Weathered shingles, repairs and apparent garage settlement**

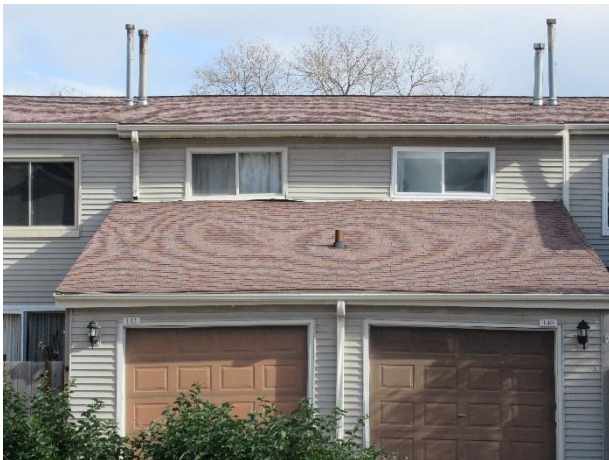
Management reports leaks primarily due to flashing issues, at chimneys, and at gutters/roof transitions lacking kick-out flashing. We recommend the Association conduct annual roof inspections and conduct this preventive maintenance practice through the operating budget.

**Roof (building) deflection, note lifted flashing and downspout discharge onto shingles**

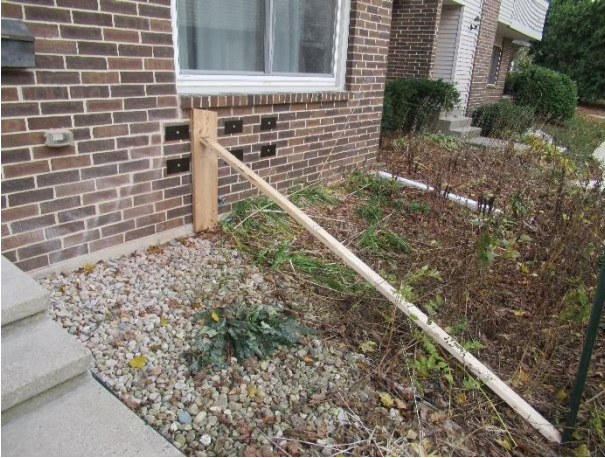
**Repairs and shoring efforts at Unit 208**

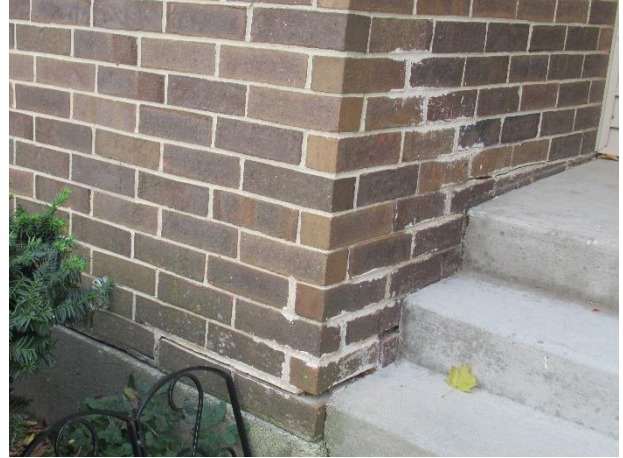
**Previous repairs, separation of mortar and masonry, and stoop settlement. Unit 212 shown.**

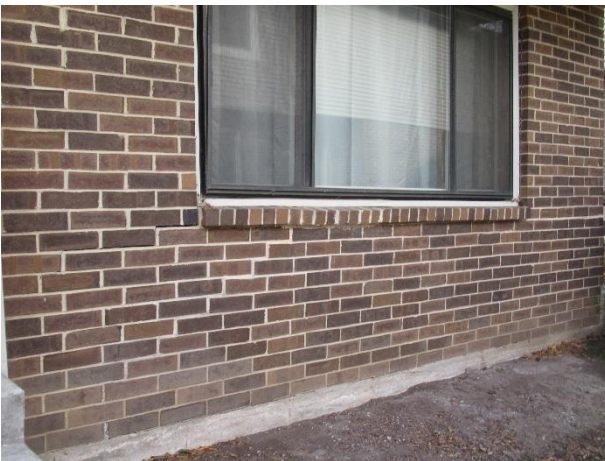
**Masonry bowing and mortar bed separation at Unit 212**

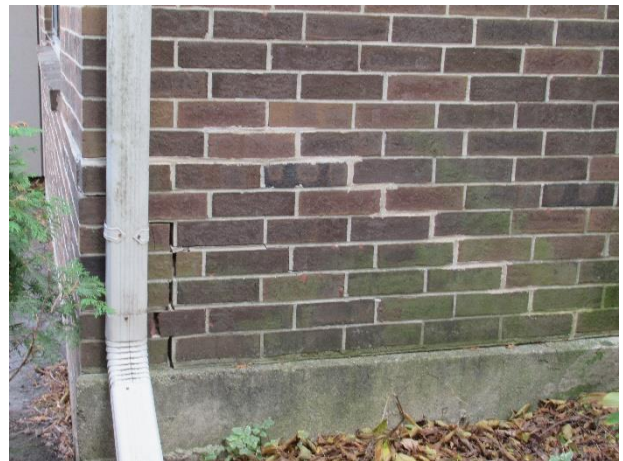
**Mortar and masonry step cracks and previous repairs**

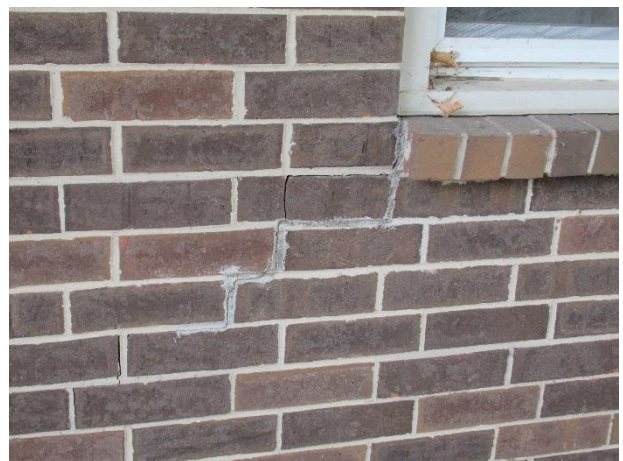
**Masonry and mortar step cracks, note previous repairs**

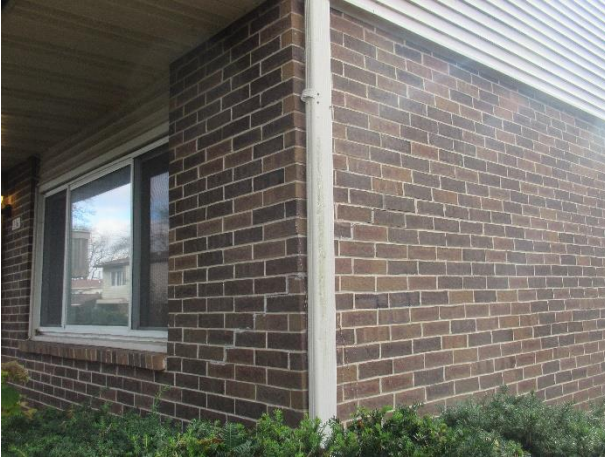
**Step cracks at two elevations, Unit 216 shown**

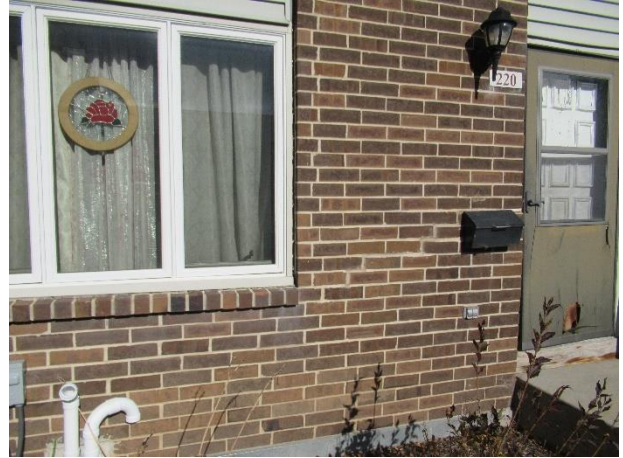
**Step cracks at Unit 220**

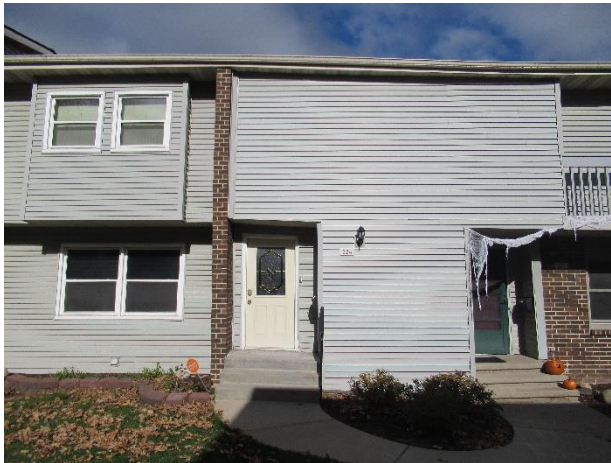
**Apparent building settlement, masonry out-of-plumb, Unit 224 shown**

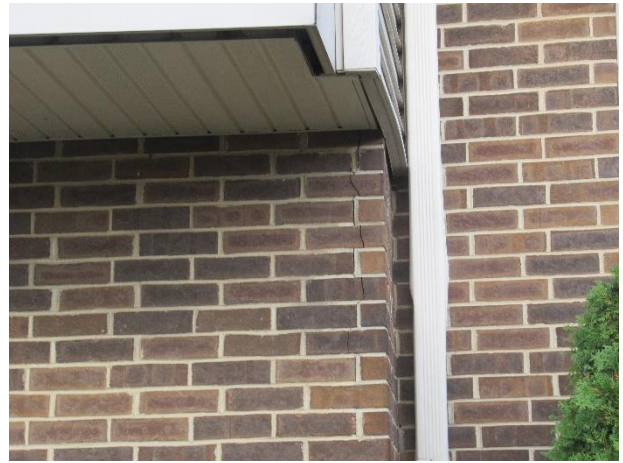
**Vertical cracks, Unit 246 shown**

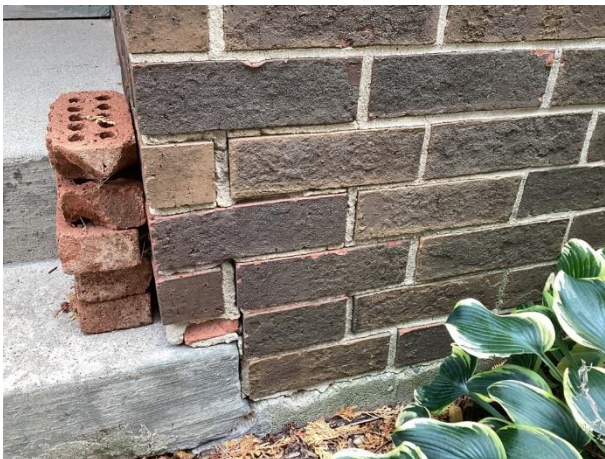
**Mortar deterioration at Unit 214**

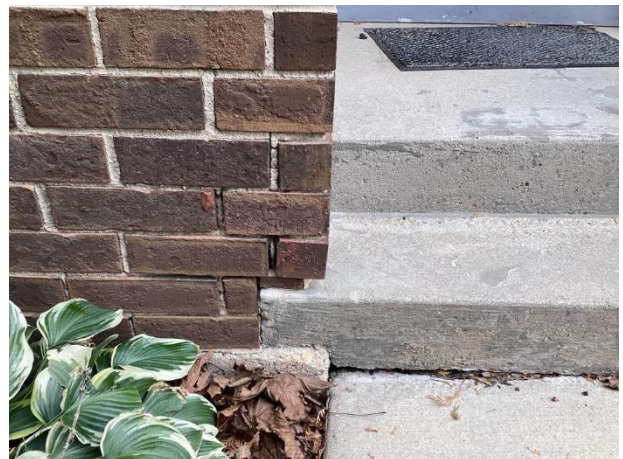
**Mortar deterioration and missing mortar at Unit 214**

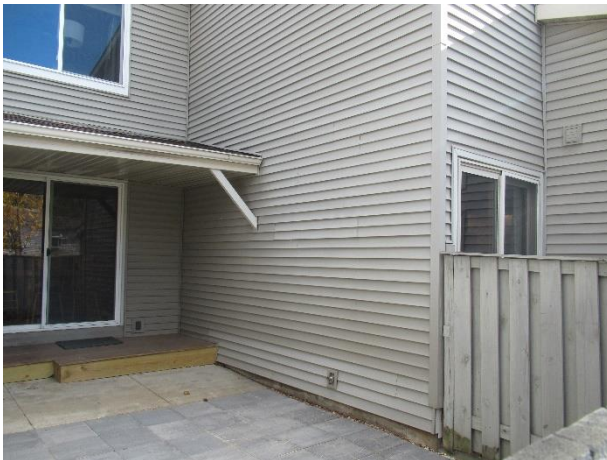
**Condition:** Fair overall with warps, bulges, loose sections and damage evident.

Partial replacements, note varied colors

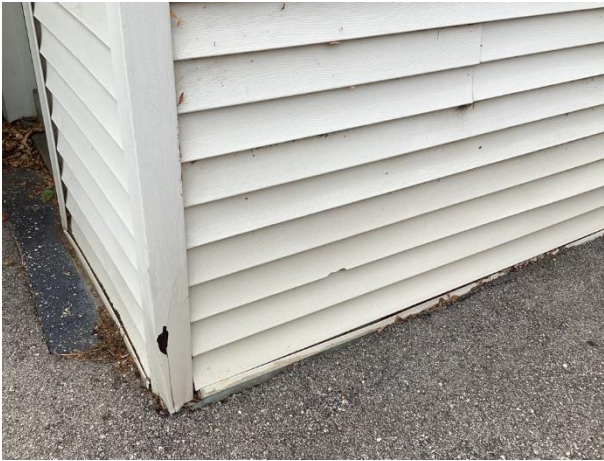
**Minor damage at clubhouse**

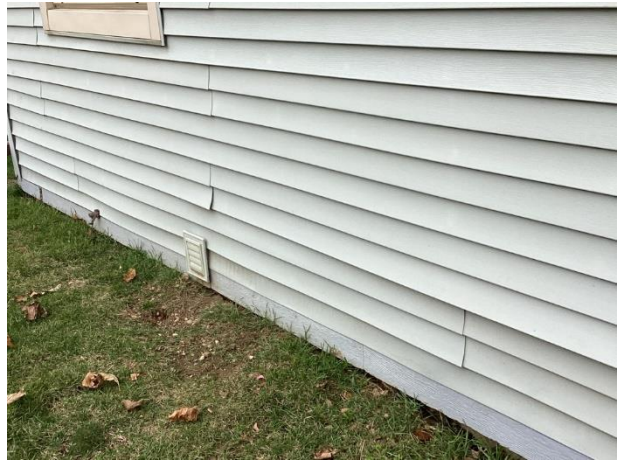
**Siding lift at Unit 214**

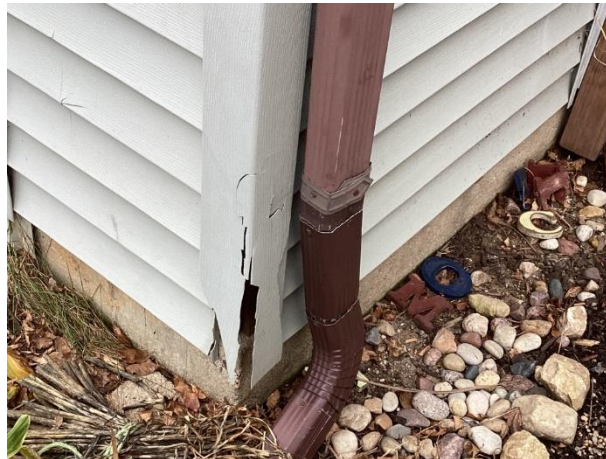
**Trim damage**

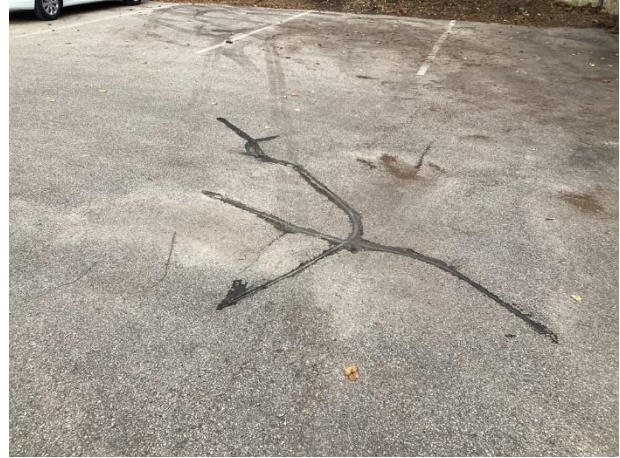
**Pavement cracks**

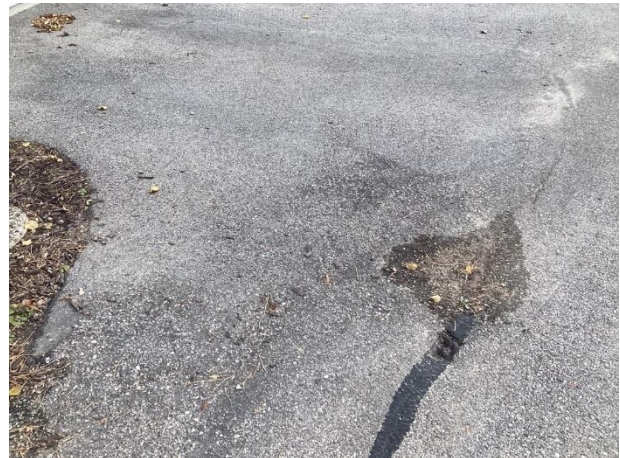
**Isolated pavement deterioration**

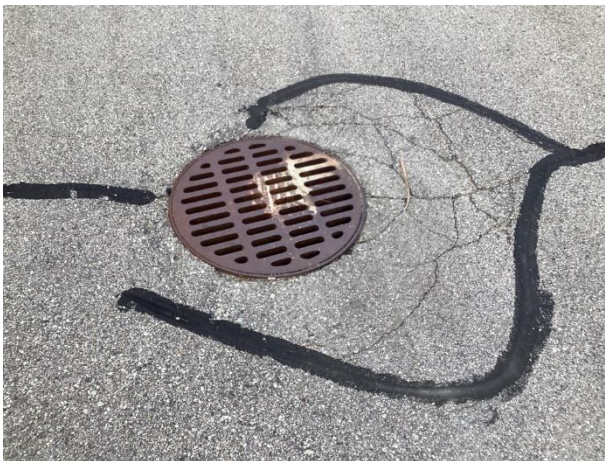
**Condition:** Good to fair overall with settlement evident.

Catch basin settlement, note pavement cracks

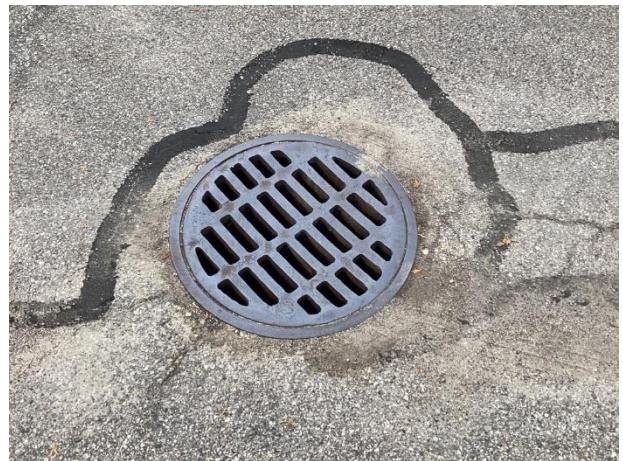
Catch basin settlement, note pavement deterioration

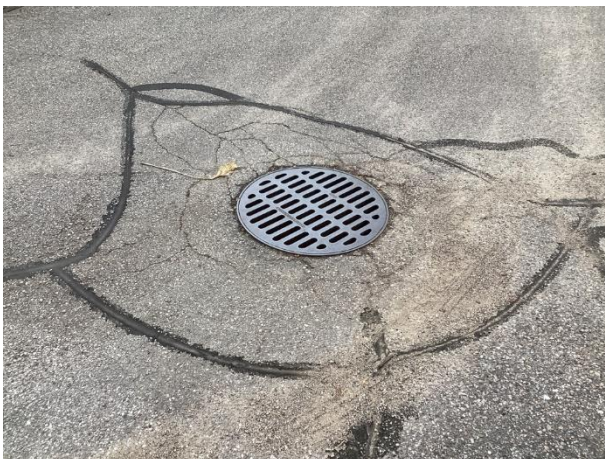
Catch basin settlement, note pavement cracks

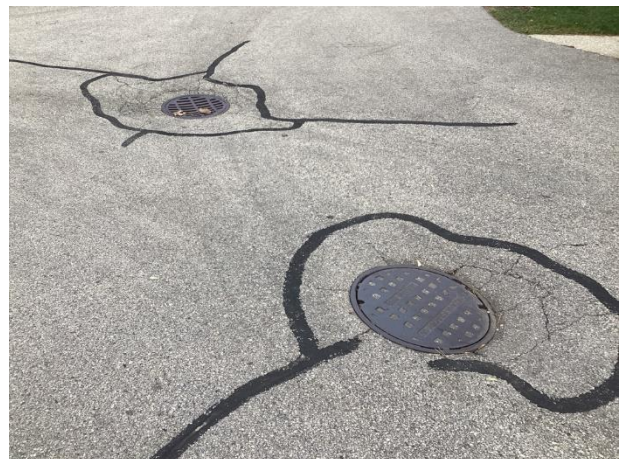
Minor catch basin settlement, note pavement cracks

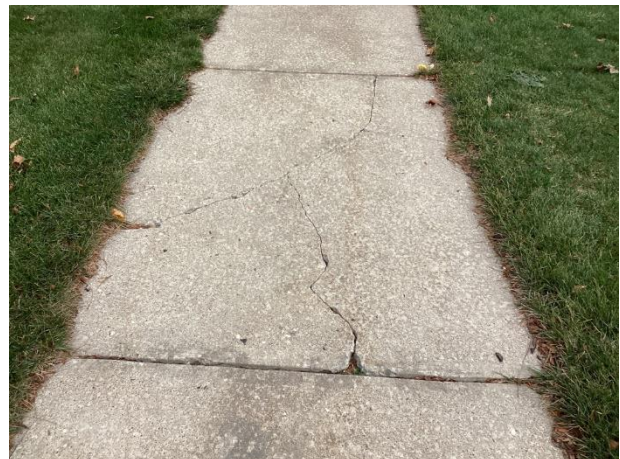
Sidewalk cracks

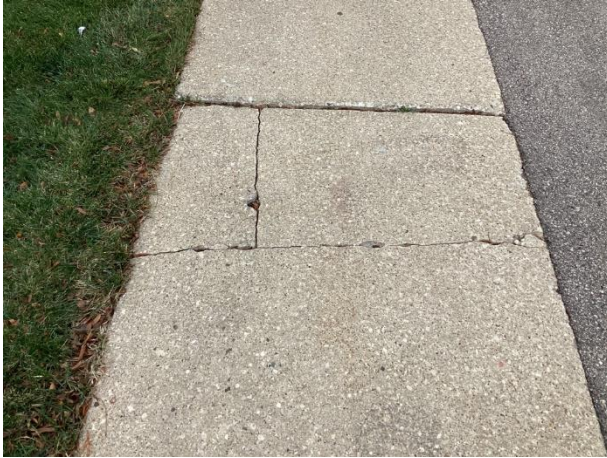
**Sidewalk cracks near clubhouse**

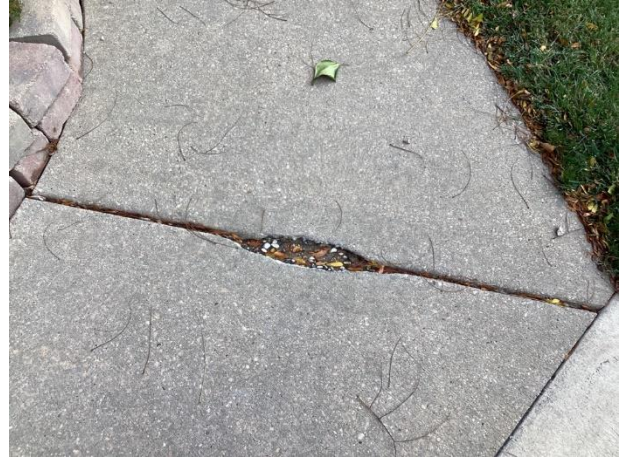
**Concrete deterioration**

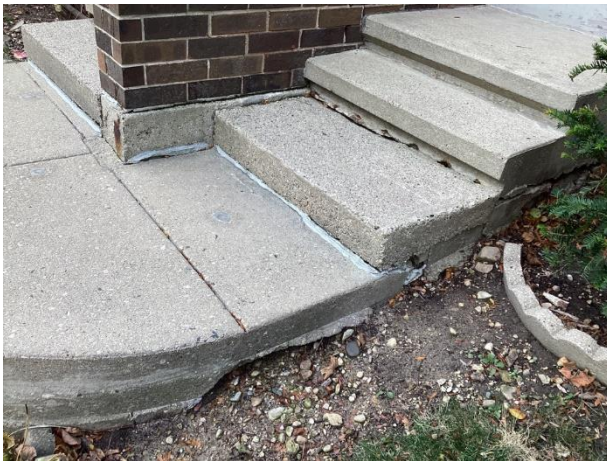
**Soil undermining at Unit 112 sidewalk**

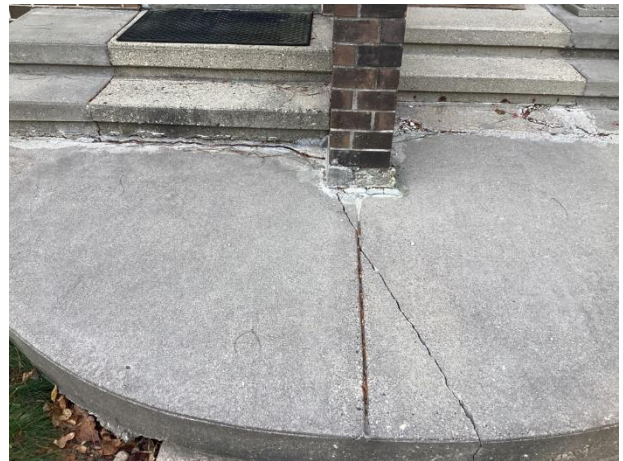
**Sidewalk cracks Units 106 - 108**

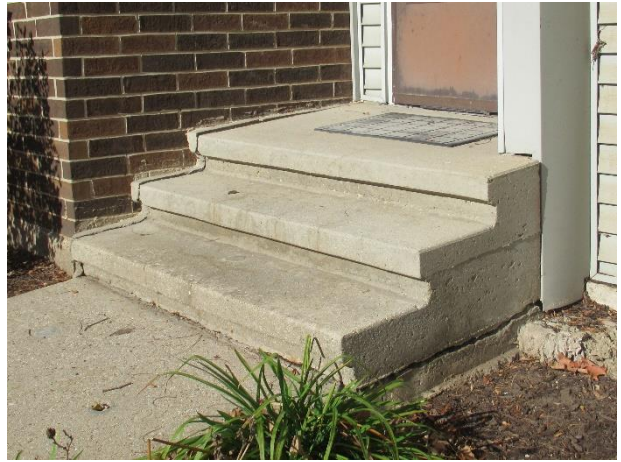
**Condition:** Fair overall with frequent settlement and spalled concrete evident. We significant apparent stoop settlement and movement, in addition to several other indicators of excessive settlement including roof deflections and masonry cracks, movement and apparent out-of-plumb locations. We include related recommendations in our narrative "Walls, Masonry".

**Significant stoop settlement, note cracks along wall and slab, Unit 226 shown**

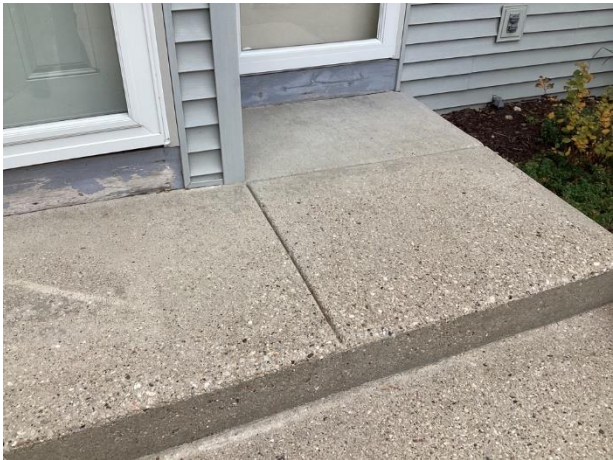
**Stoop spalls**

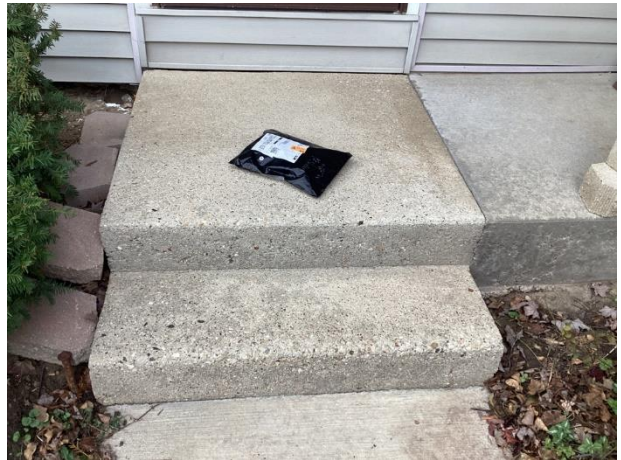
**Stoop spalls**

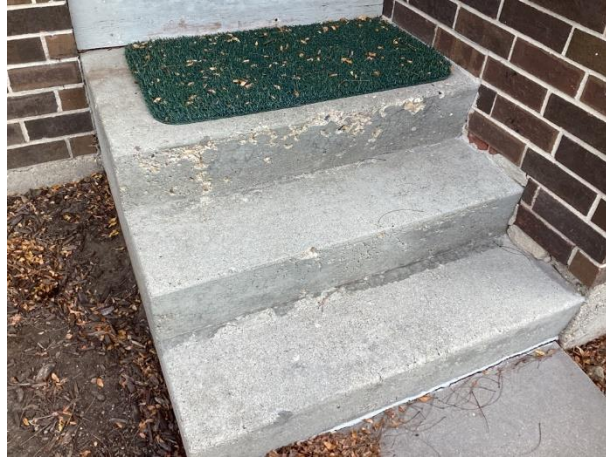
**Stoop spalls**

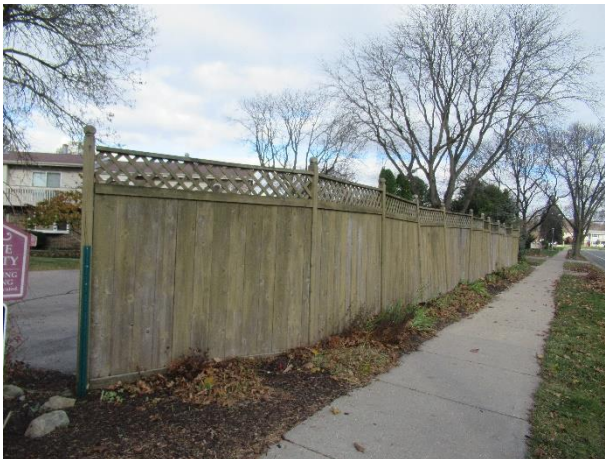
**Condition:** The fences vary in age and condition, and the older fence exhibit wood deterioration and rot, and peeling and deteriorated paint throughout. The recent replaced fences are in good condition.

**Grand Canyon Drive fence, note deflection and faded finishes**

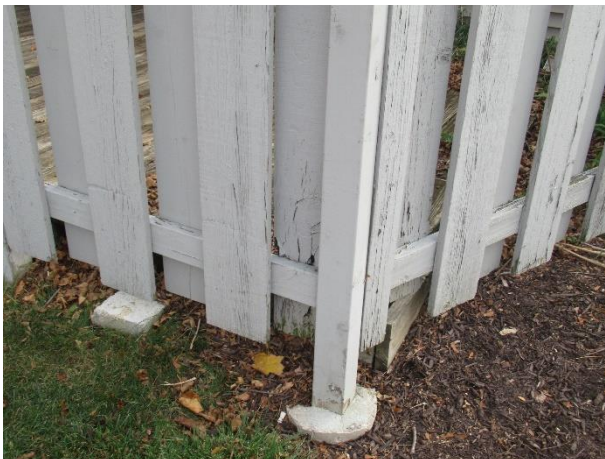
**Fence wood deterioration**

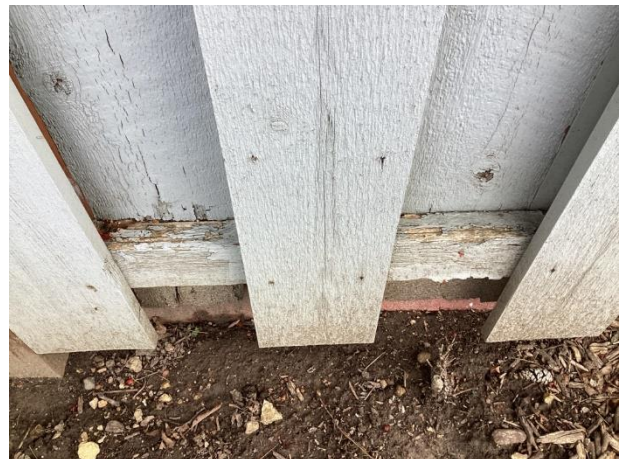
**Fence deterioration and damage**

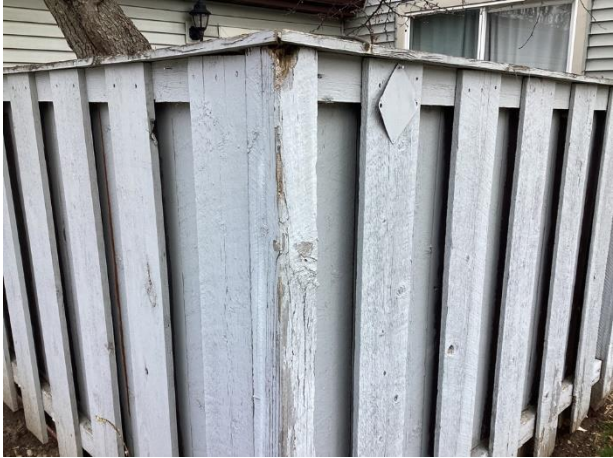
**Fence deterioration**

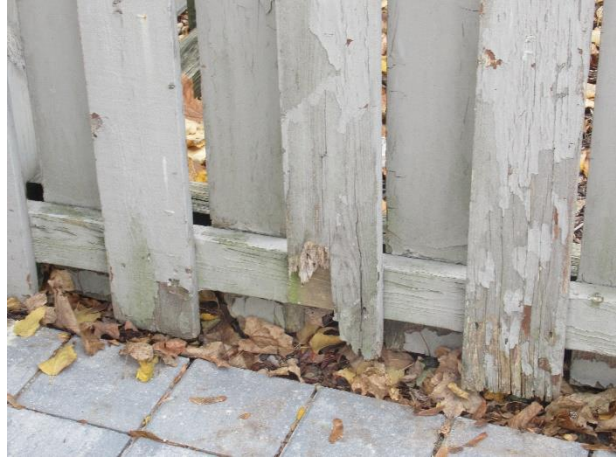
**Fence deterioration**

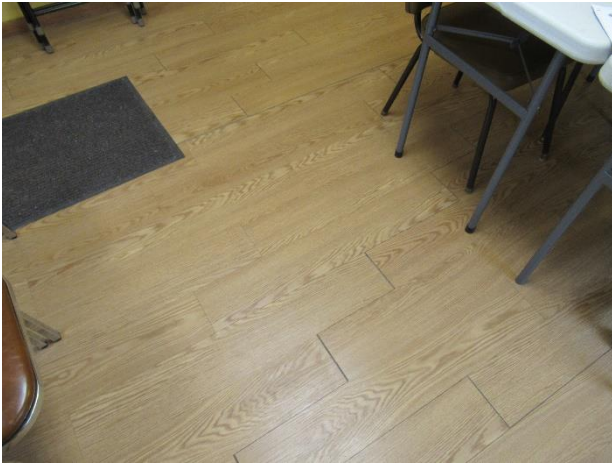
**Condition:** Fair overall with gaps at seams. The Board finds the flooring satisfactory.

**Gaps at seams (photo from 2020 inspection)**

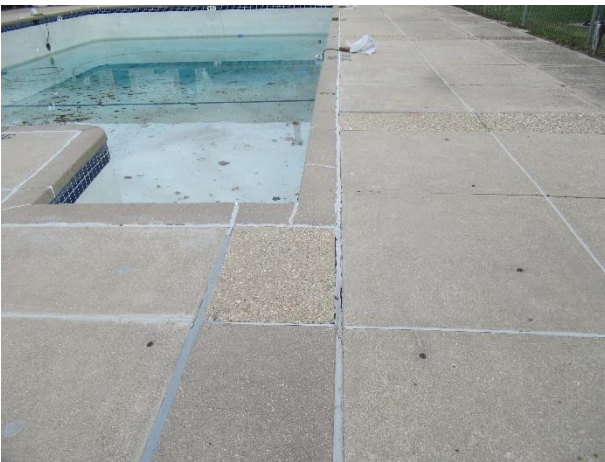
**Condition:** Good to fair overall with cracks, sealant deterioration and minor settlement evident.

**Pool deck overview, note sealant deterioration**

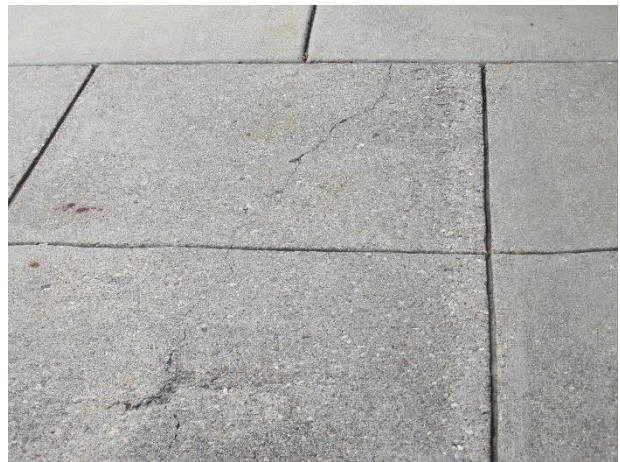
**Deck cracks**

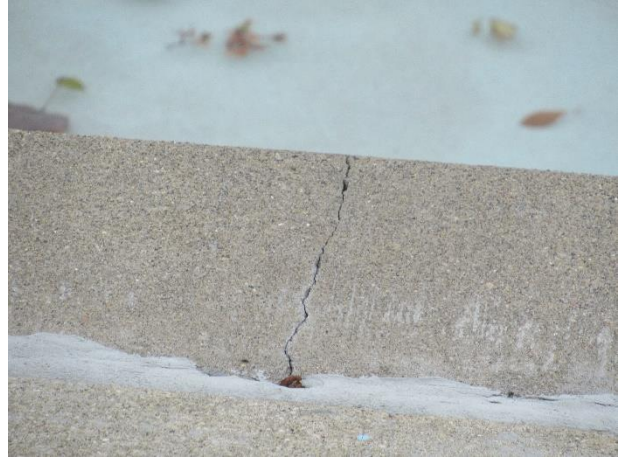
**Coping crack**

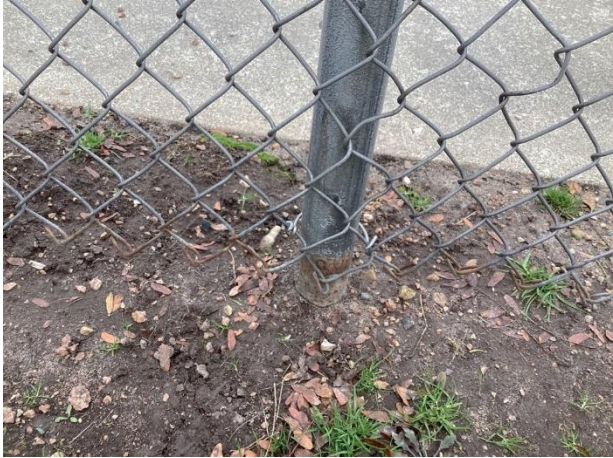
**Condition:** Fair overall with webbing warp and rusted components evident.

**Rust corrosion**

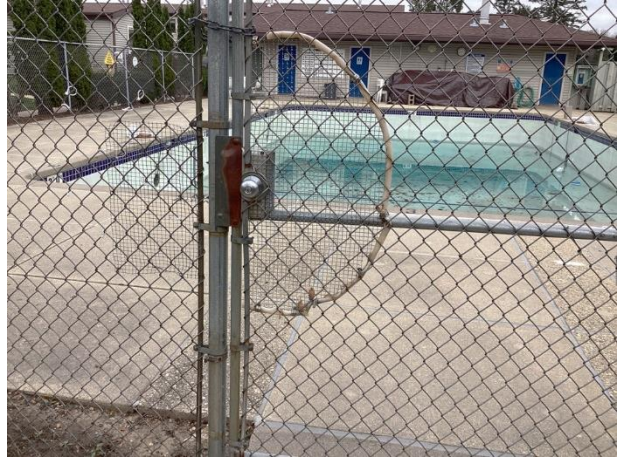
**Fence and gate rust**
