Revised
RESERVE STUDY
Parkwood Village
Homeowners Association

Madison, Wisconsin
Inspected - October 14, 2020
Revised - August 24, 2021

Parkwood Village Homeowners Association
Madison, Wisconsin

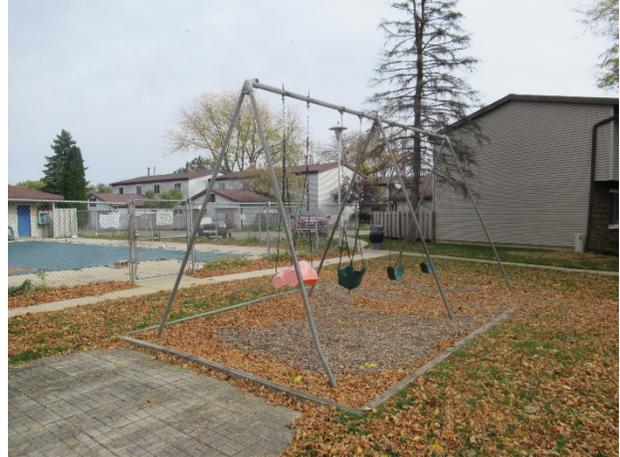
Swing set

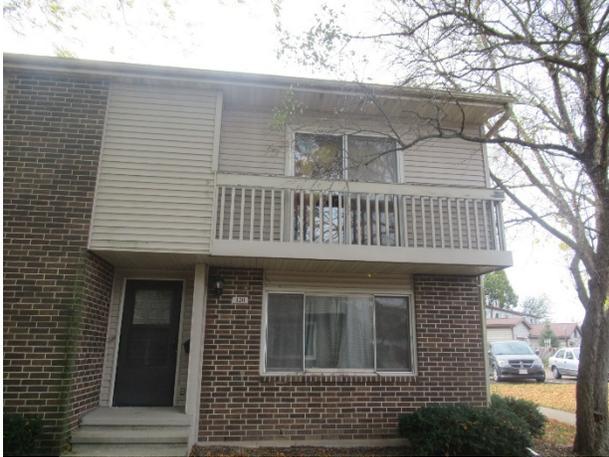
Condition: Fair overall condition with detached components, weathered wood and paint deterioration evident

Typical balcony overview

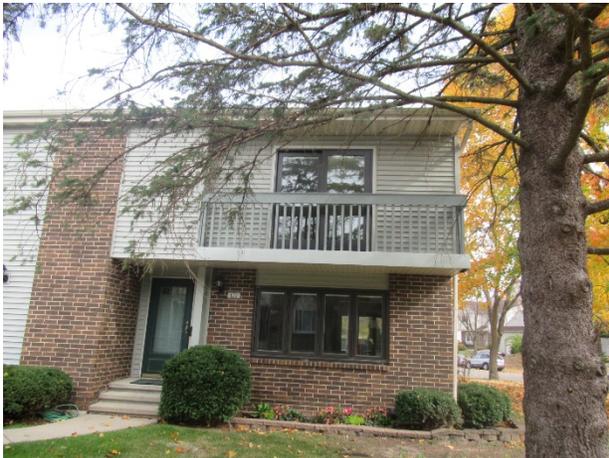
Recently replaced balcony (Unit 122 shown)

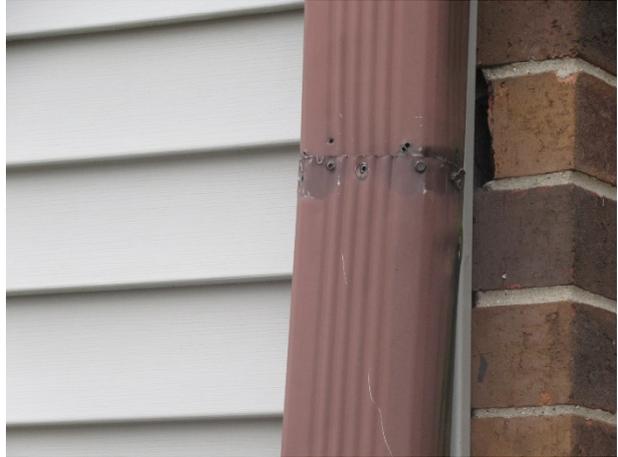
Previous repairs (Unit 2 shown)

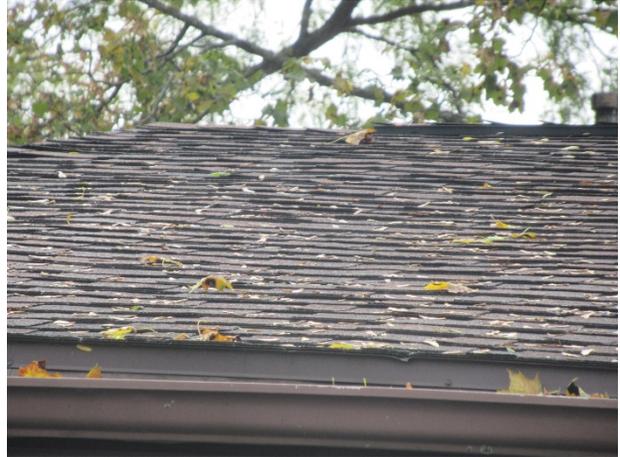
Isolated shingle lift (Unit 36 shown)

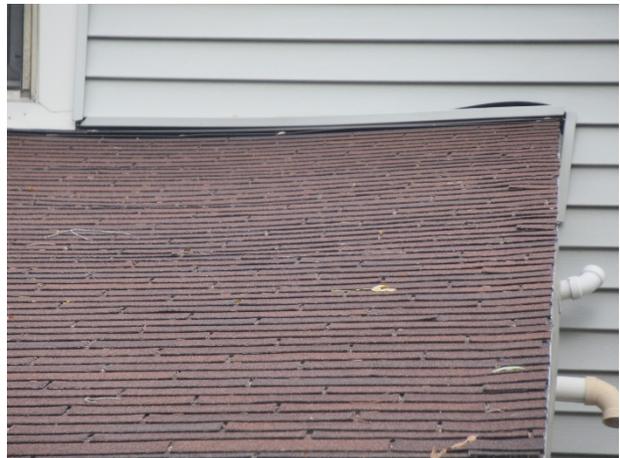
Shingle lifts (Unit 264 shown)

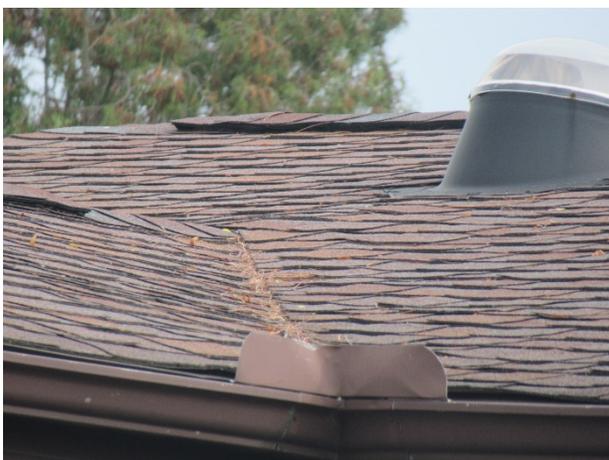
**Closed half weave valley and low pitch slope,
typical**

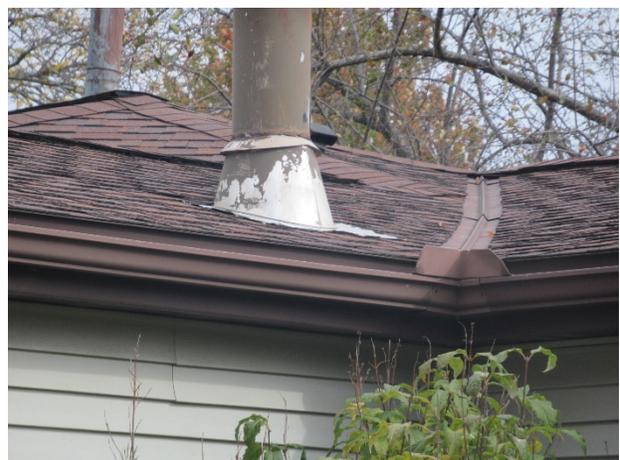
Open valley with w-flashing (Unit 214 shown)

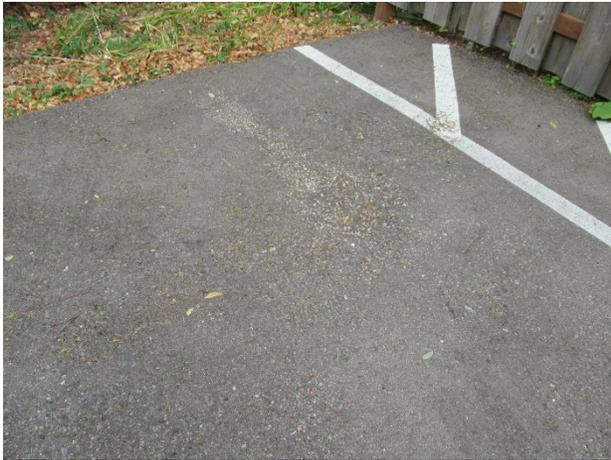
Condition: Good overall with only isolated raveling evident

Raveling spot

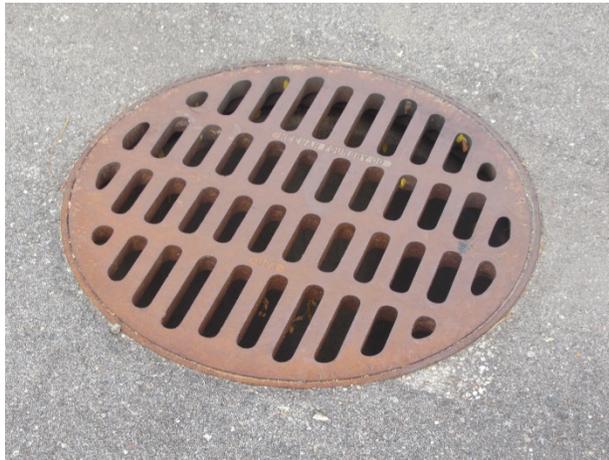
Newly installed catch basin

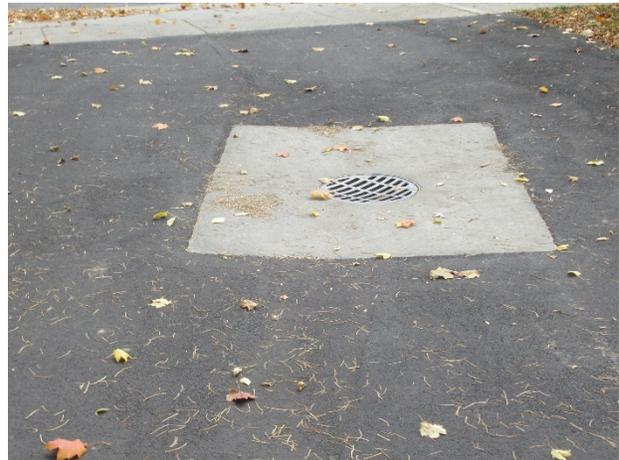
Condition: Good overall without settlement visually apparent

Existing catch basin and concrete collar

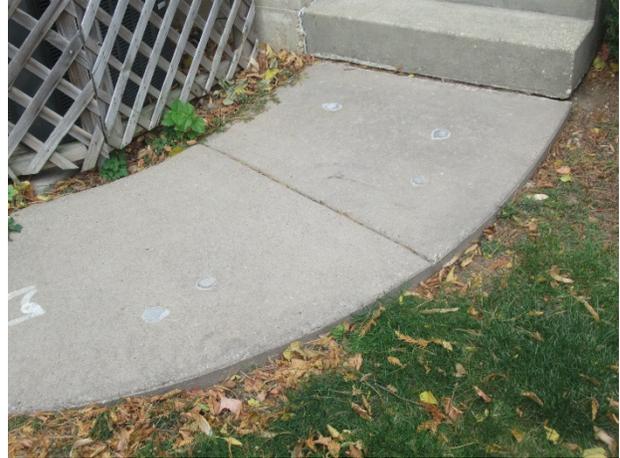
Mud jacking signs evident

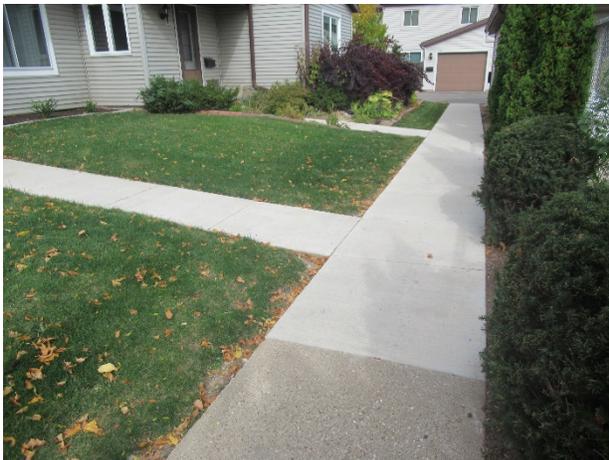
Recently replaced sidewalk

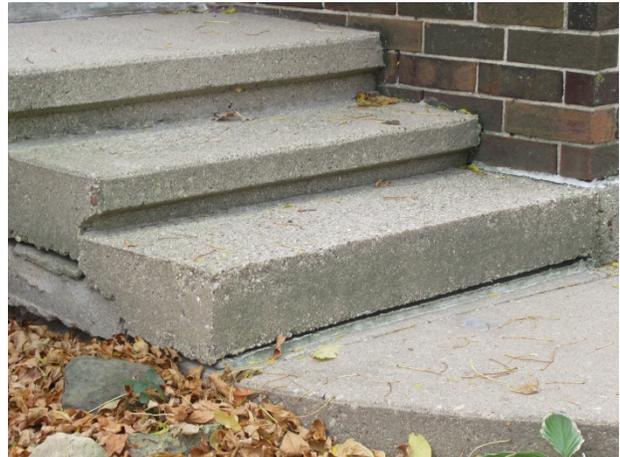
Settlement (Unit 6614 shown)

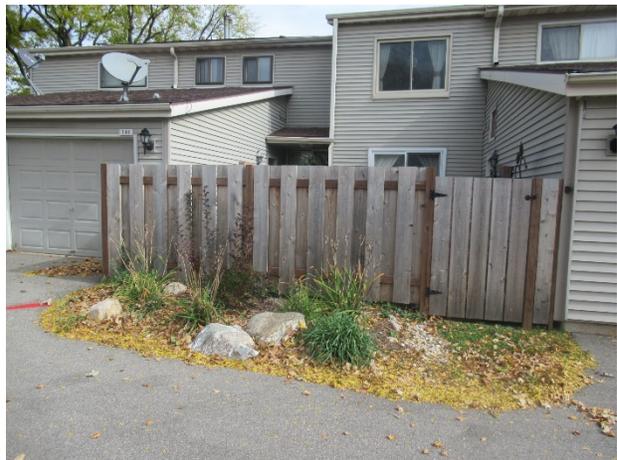
Recently replaced fence with red cedar wood (Unit 164 shown)

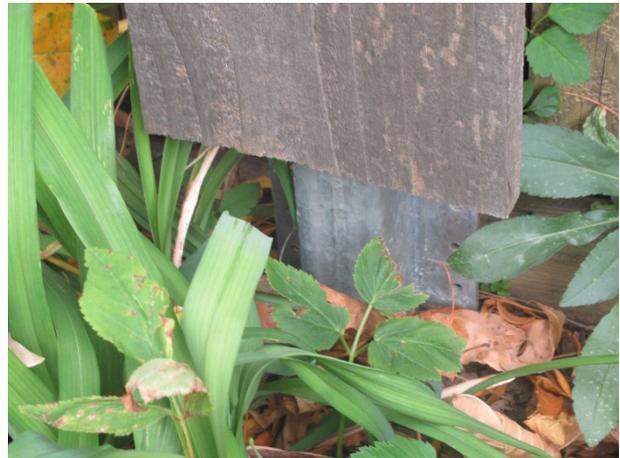
Galvanized steel post reinforcement

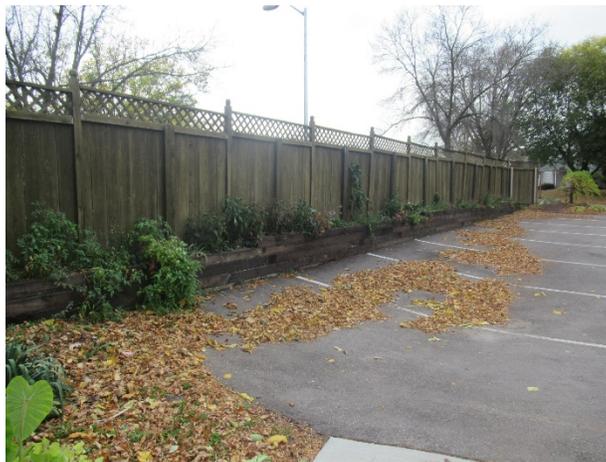
Condition: Good overall with no significant deterioration evident

Timber retaining wall

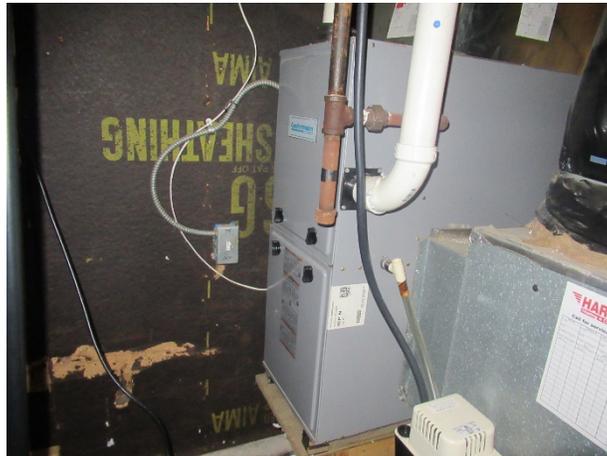
Furnace

History: Replaced in 2019

Condition: Reported in good condition without operational deficiencies

Preventative Maintenance Notes: We recommend the Association obtain and adhere to the manufacturer's recommended maintenance plan. We also recommend the Association maintain a maintenance contract with a qualified professional. The required preventative maintenance may vary in frequency and scope based on the unit's age, operational condition, or changes in technology. We note the following select recommended preventative maintenance activities to maximize the remaining useful life:

- Semi-annually:
 - Change or clean air filters as needed
 - Inspect base pan, cabinet and clear obstructions as necessary
- Annually:
 - Clean fan assembly, inspect fan drive system and controls
 - Inspect and clean accessible ductwork, pilot assembly and burners as needed
 - Check fan belt alignment and tension

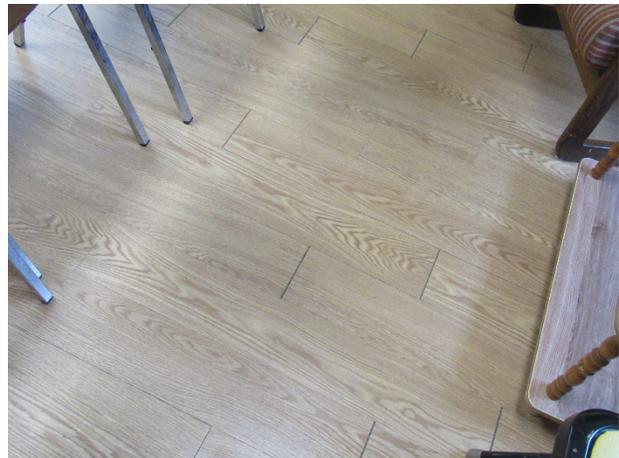
Condition: Fair overall with gaps at seams

Gaps at seams

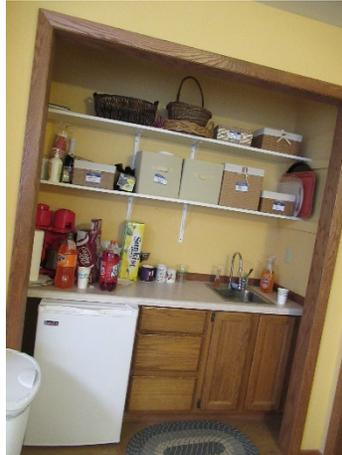
Kitchenette

History: Components are of unknown age with the exception of the fridge, sink and counters which were added in 2012

Condition: Fair overall, reported in working condition; however, components seem dated.

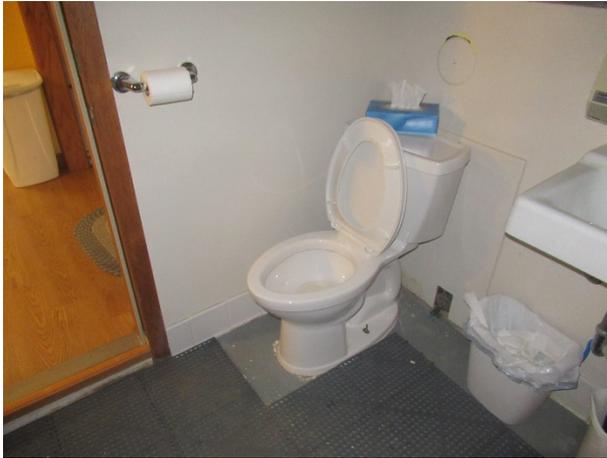
Toilet

History: Components were replaced around 2012 as part of the overall clubhouse renovation

Condition: Good to fair overall

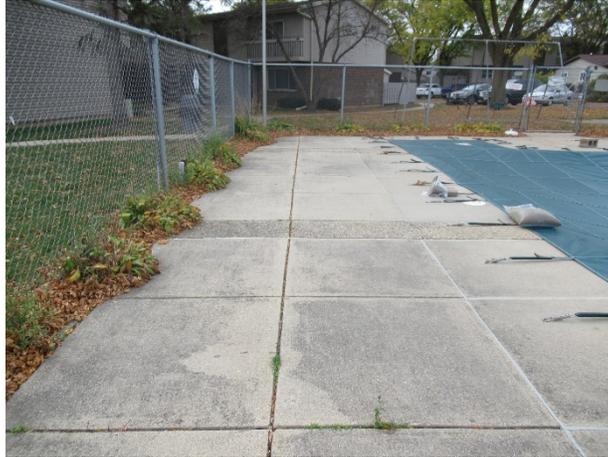
Condition: Good condition with hairline cracks evident

Caulked joints

Component Detail Notes: We recommend the Association budget for the following:

- Selective cut out and replacements of up to ten percent (10%) of concrete
- Crack repairs as needed
- Mortar joint repairs
- Caulk replacement
-

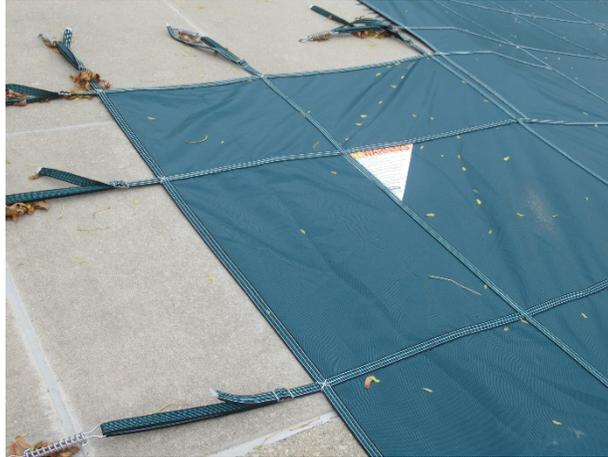
History: Replaced in 2020

Condition: Good condition (one week old at the time of inspection)

New cover

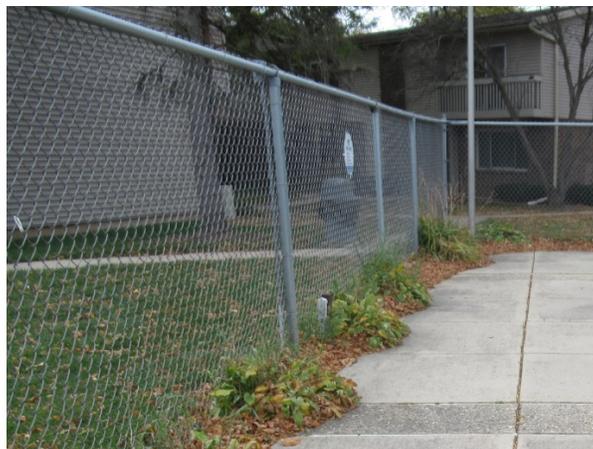
Fence overview

History: Original

Condition: Fair overall condition with no visible deterioration evident

Preventative Maintenance Notes: We note the following select recommended preventative maintenance activities to maximize the remaining useful life:

- Annually:
 - Inspect and repair loose sections, and damage
 - Repair leaning sections and clear vegetation from fence areas which could cause damage

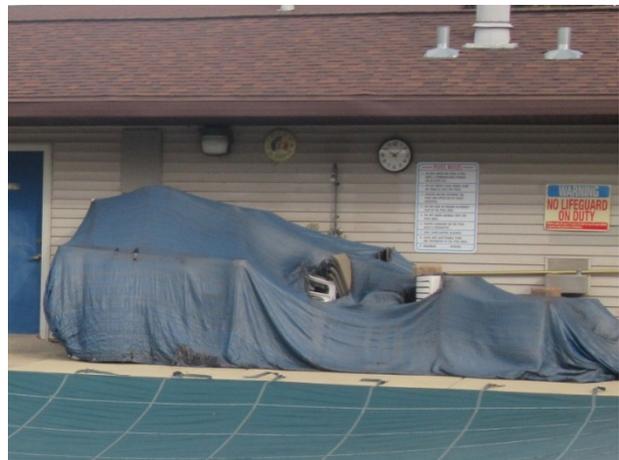
Condition: Fair to poor overall

Covered vinyl furniture

Expenditure Detail Notes: Expenditure timing and costs are depicted in the **Reserve Expenditures** table in Section 3. Our cost is based on information provided by the Association. We recommend interim re-strapping, refinishing, cushion replacements, reupholstering and other repairs to the furniture as normal maintenance to maximize its useful life.

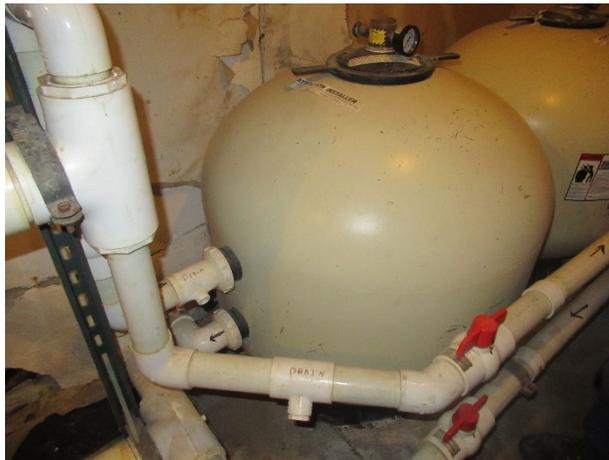
Filters

History: Ages vary, the water heater was replaced in 2017, the filters and pump were replaced in 2011.

Condition: Reported satisfactory

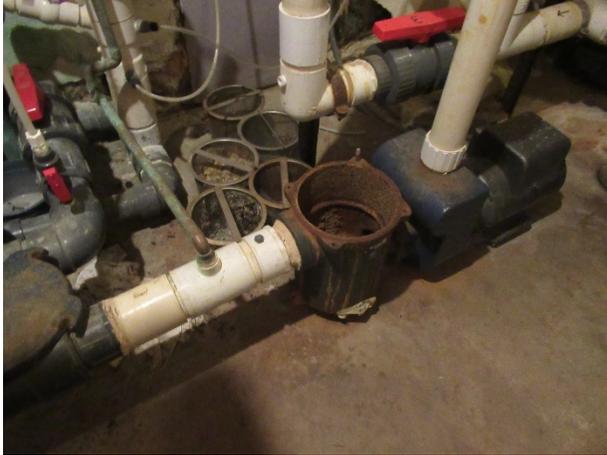
Motor housing, note rust

Expenditure Detail Notes: Expenditure timing and costs are depicted in the **Reserve Expenditures** table in Section 3. Failure of the pool mechanical equipment as a single event is unlikely. Therefore, we include replacement of up to fifty percent (50%) of the equipment per event. We consider interim replacement of motors and minor repairs as normal maintenance.
