# Parkwood Village

## Homeowners Association

Inspected: November 12, 2024 • Revised on: July 23, 2025  
Madison, WI

RESERVE STUDY

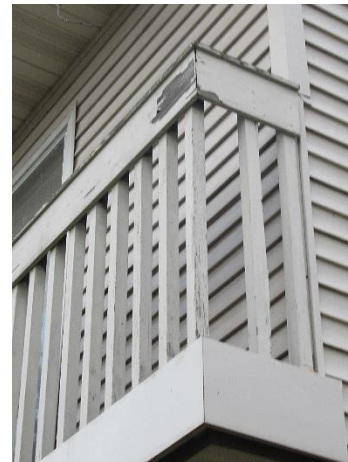
**Peeling finishes and wood deterioration**

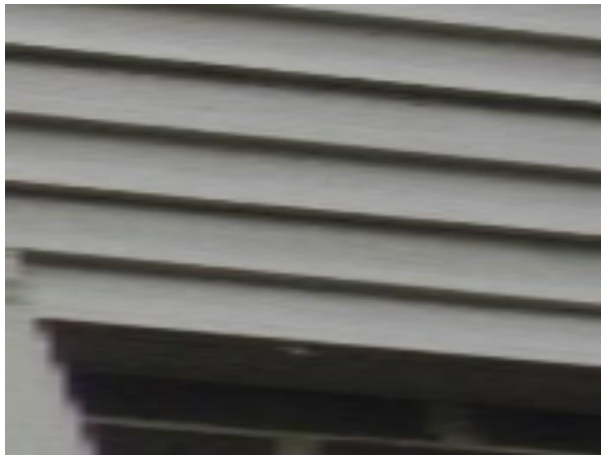
**Weathered and deteriorated wood components**

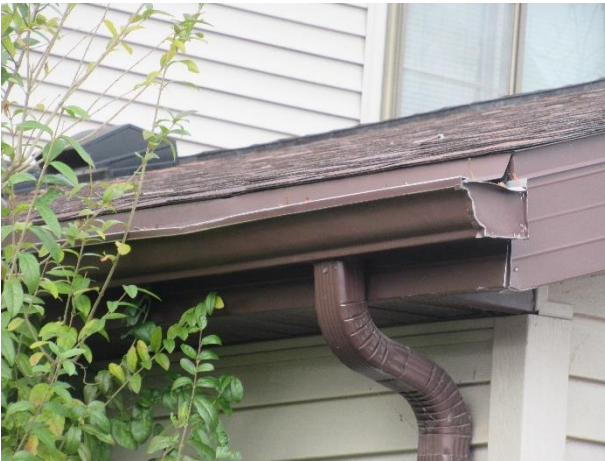
**Deflected gutters**

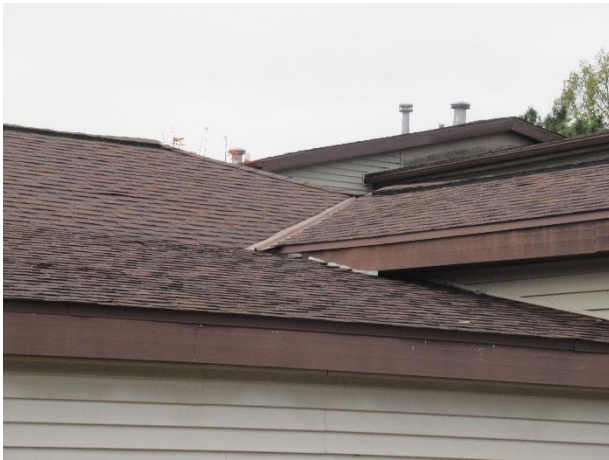
**Shingle lift at clubhouse**

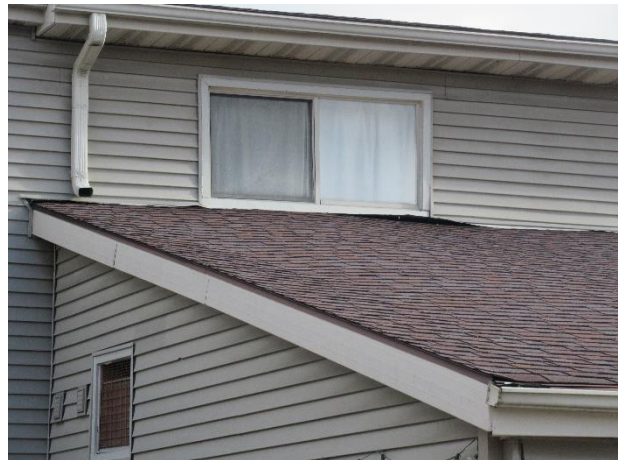
**Lifted flashing detail**

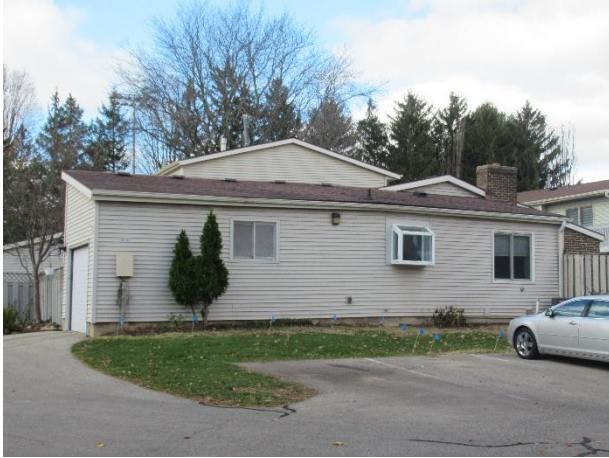
**Roof (building) deflection**

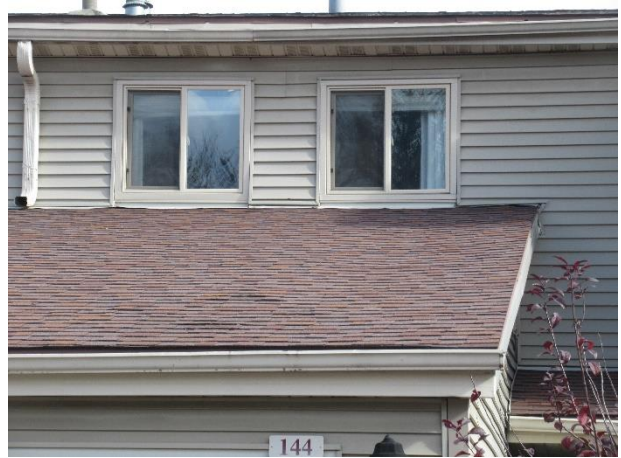
**Shingle lift and weathered shingles**

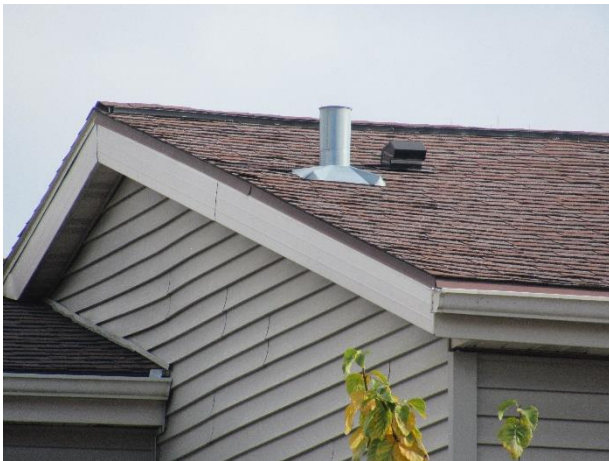
**Shingle lift and weathered shingles**

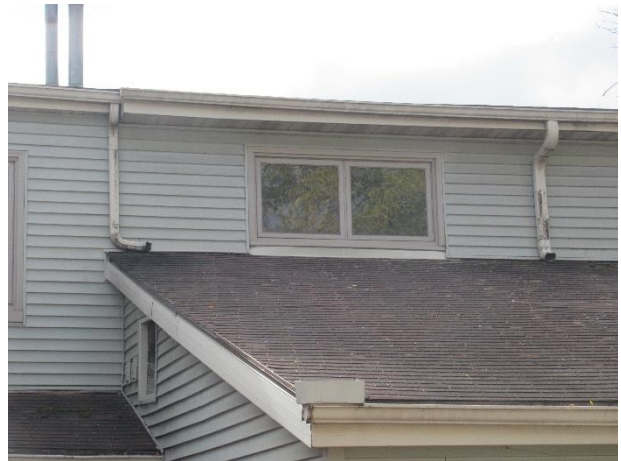
**Three-tab shingles, note weathering and granular loss**

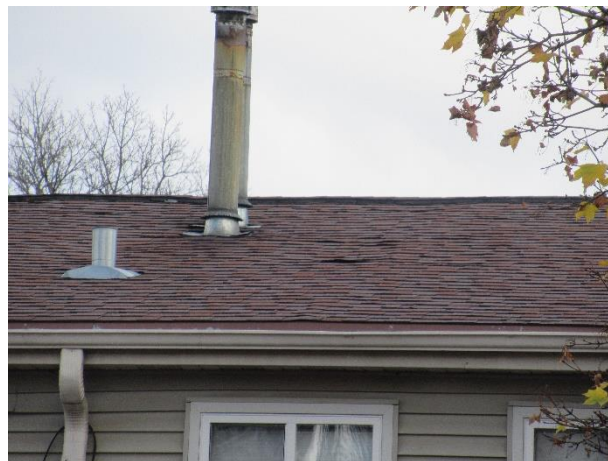
**Shingle lift and weathered shingles**

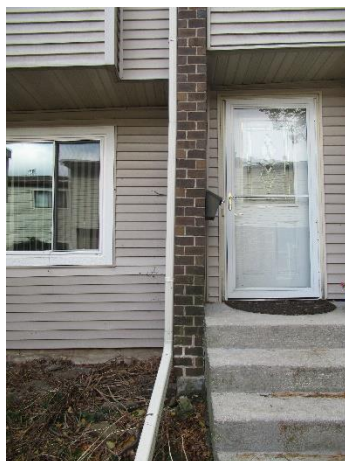
**Apparent building settlement, masonry out-of-plumb**

**Condition:** Fair overall with frequent settlement and spalled concrete evident. We significant apparent stoop settlement and movement, in addition to several other indicators of excessive settlement including roof deflections and masonry cracks, movement and apparent out-of-plumb locations. We include related recommendations in our narrative "Walls, Masonry".

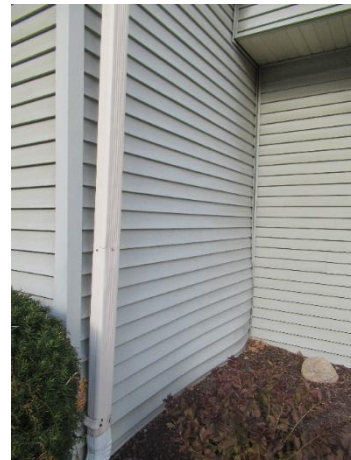
Warped/bulging siding, Unit 224 shown

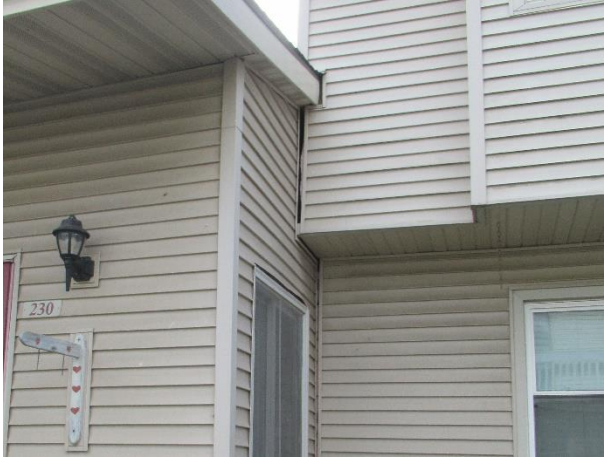
**Gaps, note separation between Units 230 and 232**

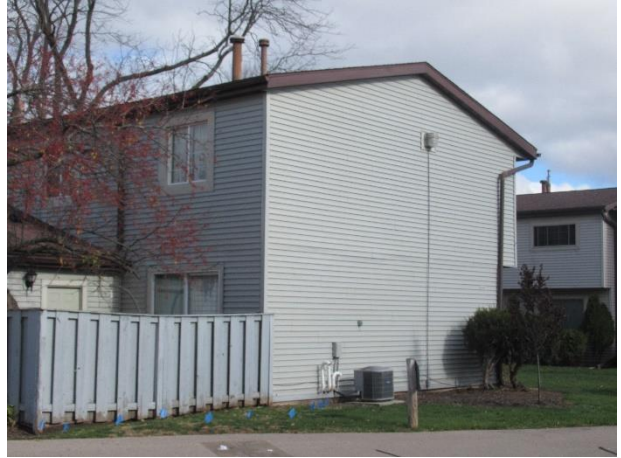
**Siding bulges**

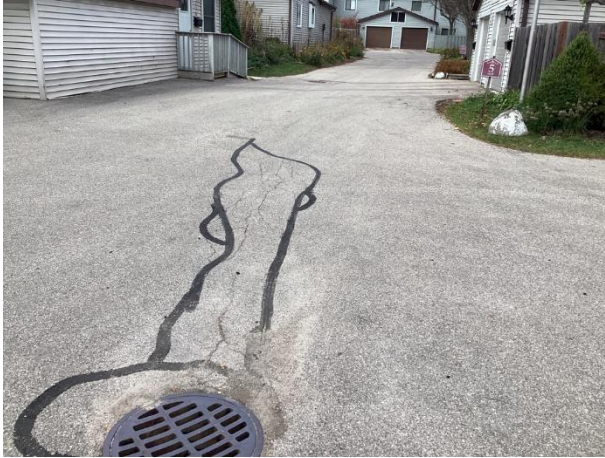
**Pavement overview, note centerline drainage cracks and previous repairs**

**Component Detail Notes:** Proposals should include mechanically routing and filling all cracks with hot emulsion. Repairs should also include patching at areas exhibiting settlement, potholes, or excessive cracking. The contractor should only apply seal coat applications after repairs are completed. A seal coat does not bridge or close cracks, therefore, unrepaired cracks render the seal coat applications useless. These activities minimize the damaging effects of vehicle fluids, maintain a uniform and positive appearance, and maximize the useful life of the pavement.

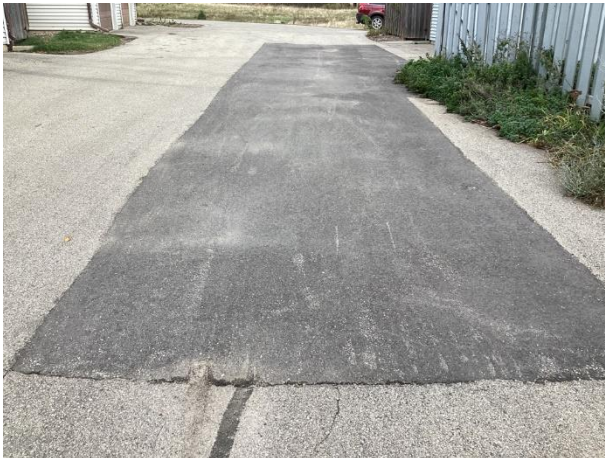
**Isolated significant patch**

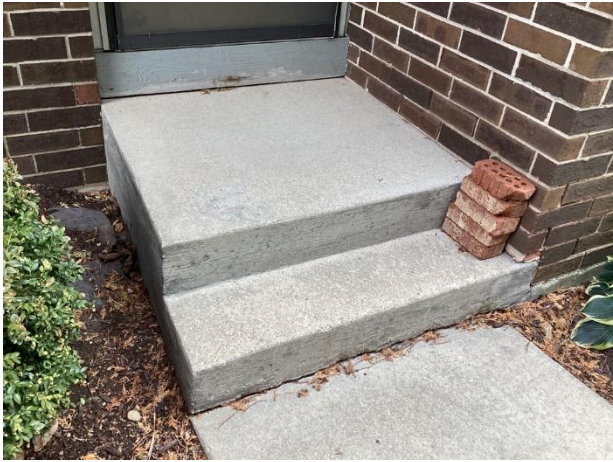
**Typical concrete stoop**

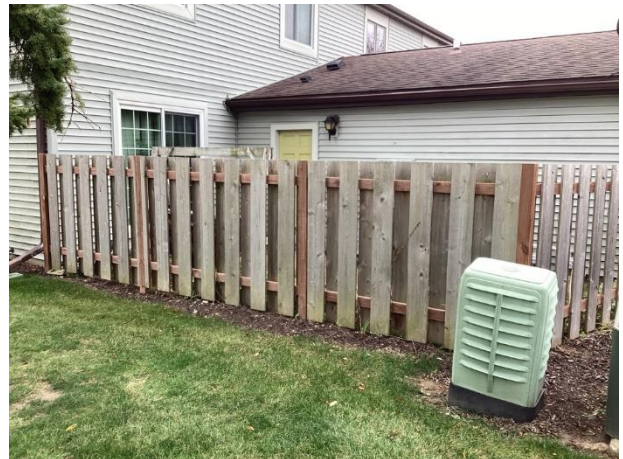
**Replaced wood fence posts at patio**

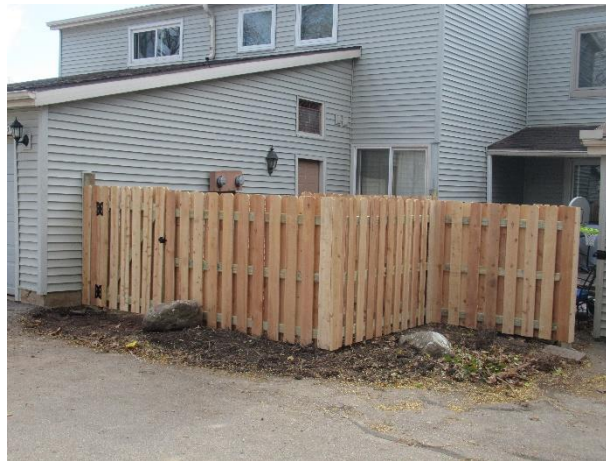
**Replaced fence in good condition**

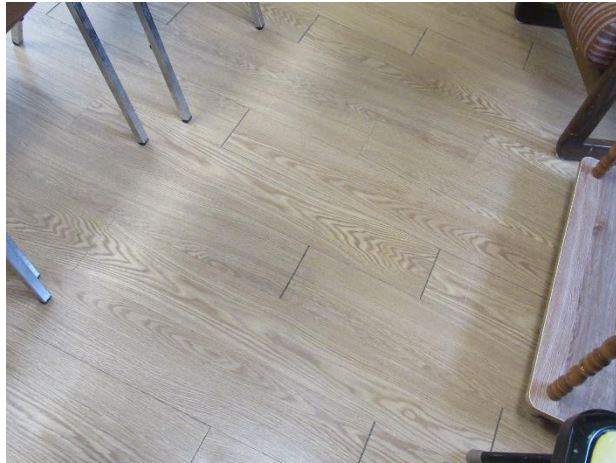
**Condition:** Fair overall with gaps at seams. The Board finds the flooring satisfactory.

**Gaps at seams (photo from 2020 inspection)**

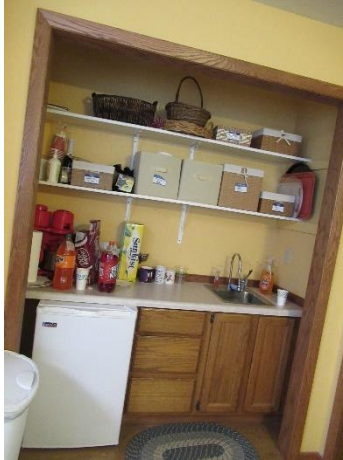
**Condition:** Fair overall, reported in working condition; however, components appear dated.

**Kitchenette** (*photo from 2020 inspection*)

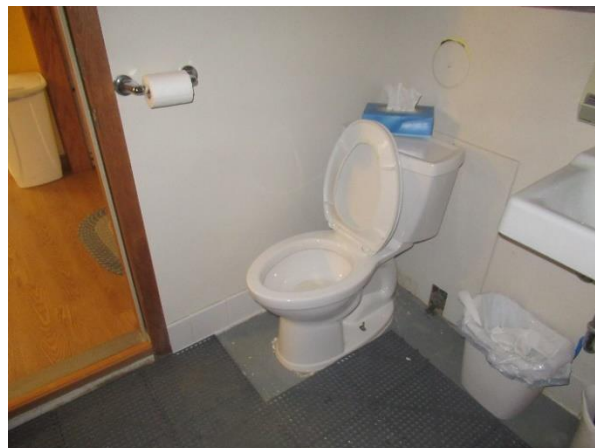
**Condition:** Good to fair overall

**Rest room** (*photo from 2020 inspection*)

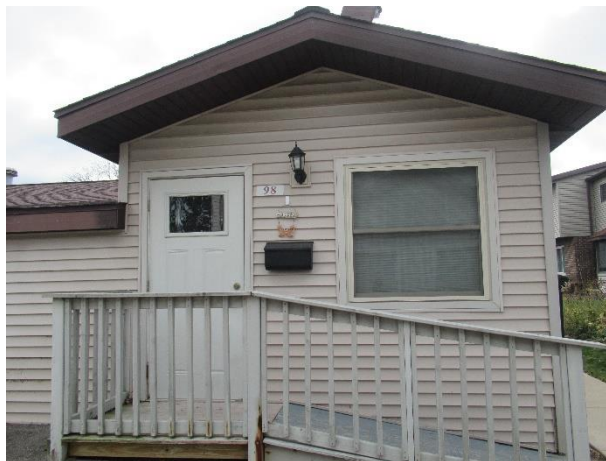
**Condition:** Good to fair overall

***Windows and doors***

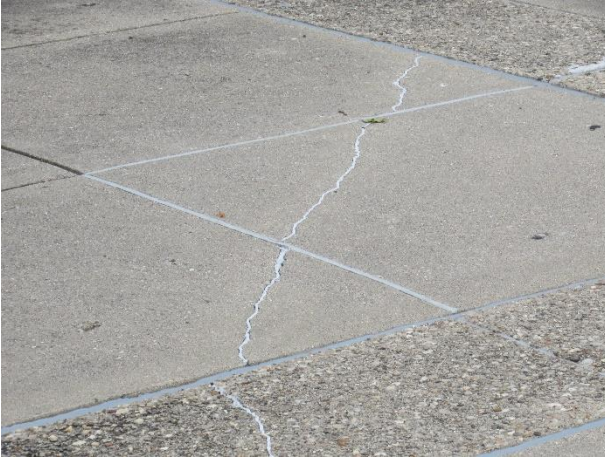
**Condition:** Good to fair overall with cracks, sealant deterioration and minor settlement evident.

**Previous cracks repairs**

- Selective cut out and replacements of up to ten percent (10%) of concrete
- Crack repairs as needed
- Mortar joint repairs
- Caulk replacement

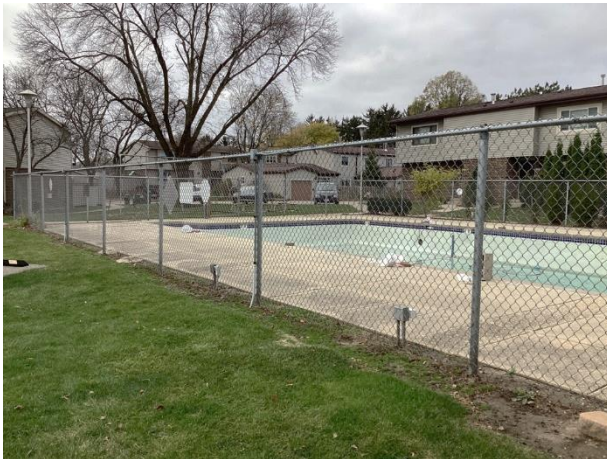
**Condition:** Fair overall with webbing warp and rusted components evident.

**Pool chain link fence**

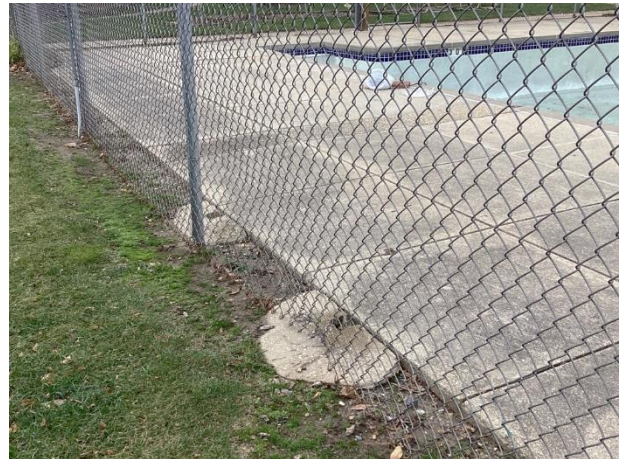
**Webbing warp**

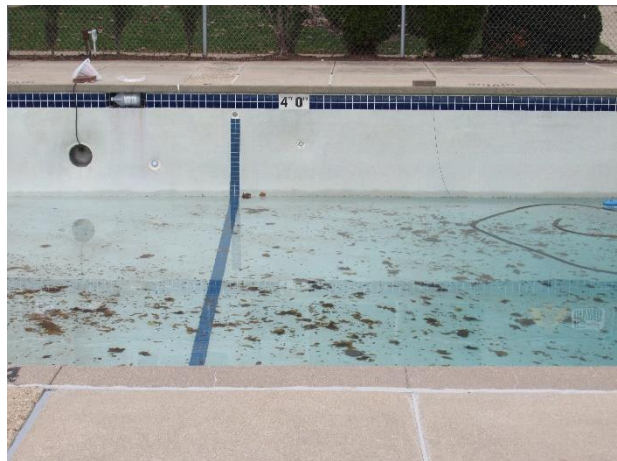
**Condition:** Fair overall with staining noted. Management does not report cracks at the pool structure or water loss.

**Pool finishes**
